EPA's Audit of SLCO's Phase 1 Stormwater Program and Lessons Learned

Background:

- Salt Lake County is a Co-permittee with 14 other Cities authorized to discharge municipal stormwater under the Jordan Valley Municipalities Permit No. UTS000001
- Salt Lake County is a Phase 1 MS4 (population greater than 100,000); additional monitoring and high-risk industrial programs; 1st permit was issued in 1995
- MS4 Jurisdiction covers un-incorporated areas of Salt Lake County and County-wide Flood Control facilities
- Next permit cycles were in 2001, 2006, 2013 (current expires in Sept 2018)
- County was audited by State DWQ in 2007 (12 findings)
- The EPA conducted a Compliance Evaluation Inspection (CEI) "Audit" on March 5-9, 2012

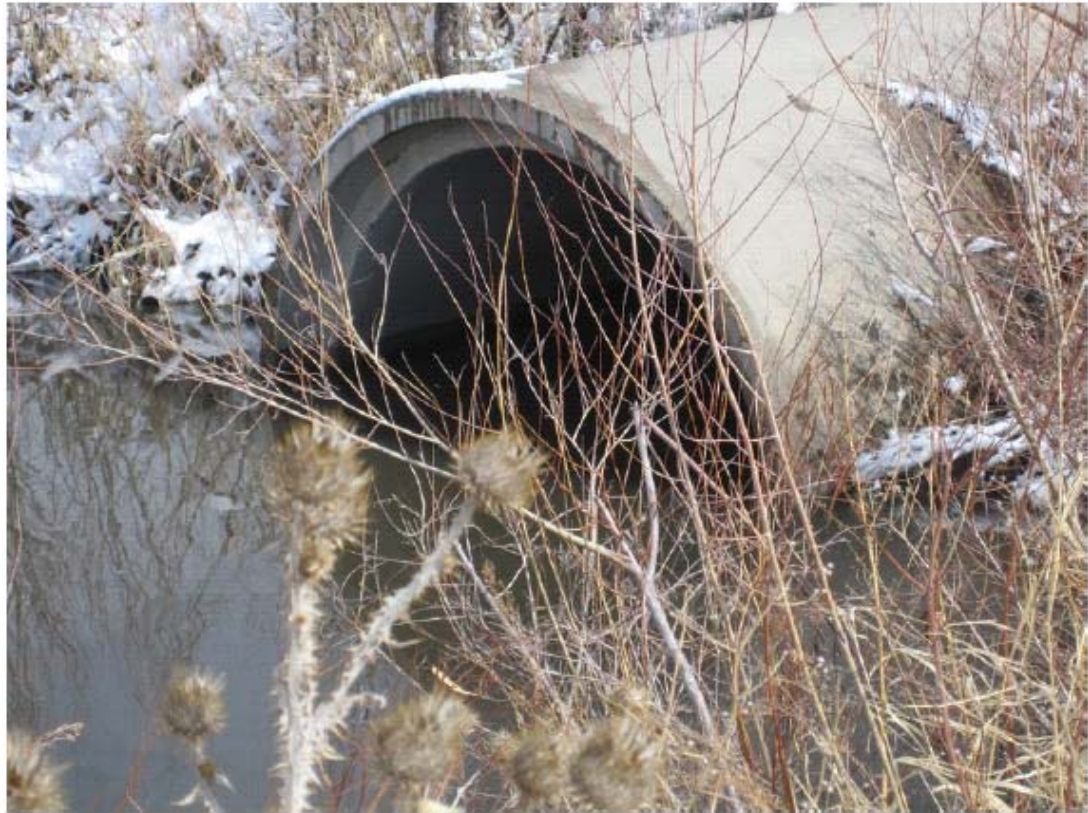
Photo Number 1177
Inspection Date 3/7/2012
Photographer A. Clark
Description Inlet at monitoring location JOR-1 (same inlet as photo 1174). Note inlet is blocked and pipe is half submerged with sediment.

Finding 1MN – Inadequate Wet Weather Monitoring Locations and Maintenance Issues

Corrective Action – Site was decommissioned

3 new sites were installed to be more representative of County MS4

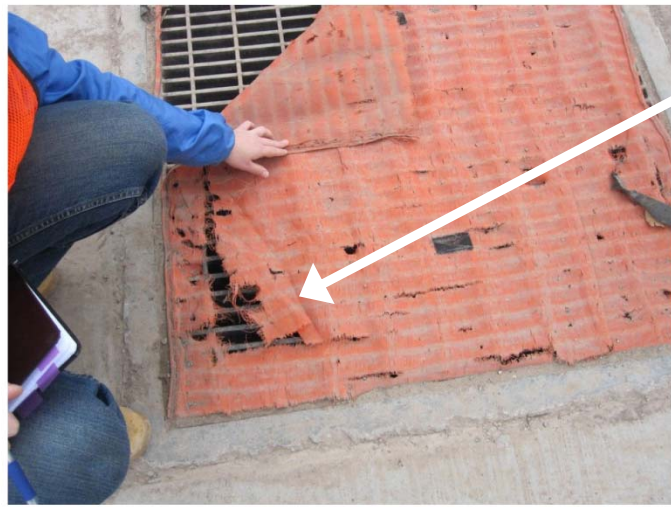
Photo Number 1152
Inspection Date 3/6/2012
Photographer A. Clark
Description Storm inlet catch basin with torn dandy bag at the Millcreek Community Center.

Torn Dandy Bag

Sediment

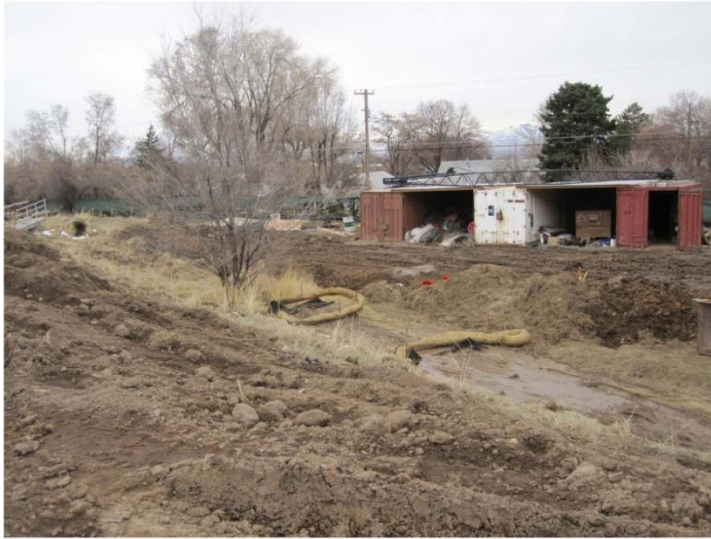
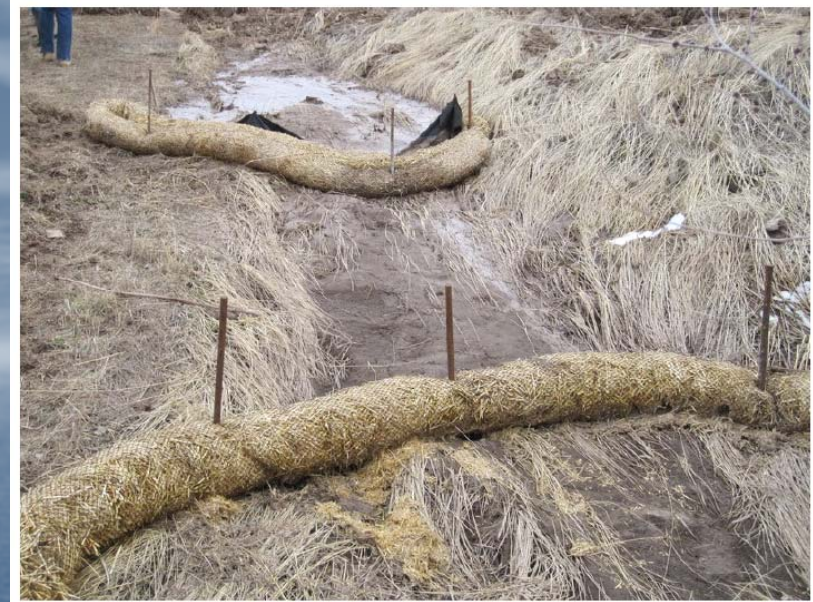
1143
3/6/2012
A. Clark
Natural drainageway
to Parley's Creek.
This was also the
conveyance water
from the accidental
potable water
discharge at the
Terminal Reservoir
site.

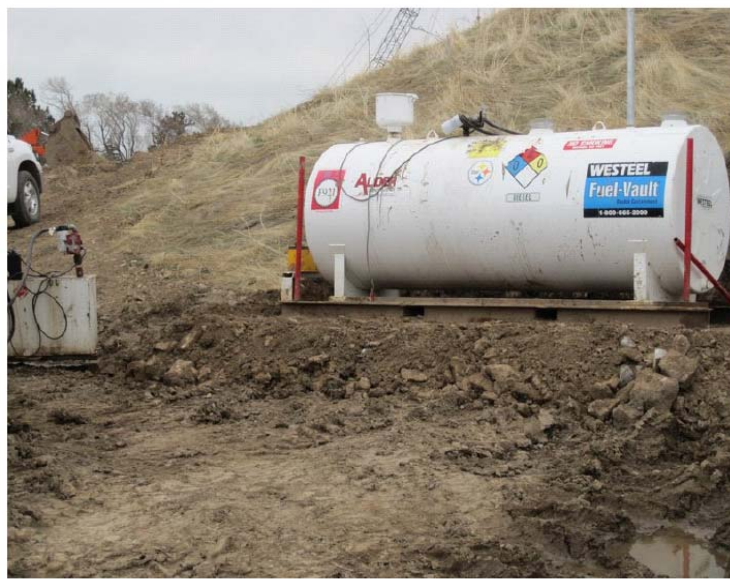
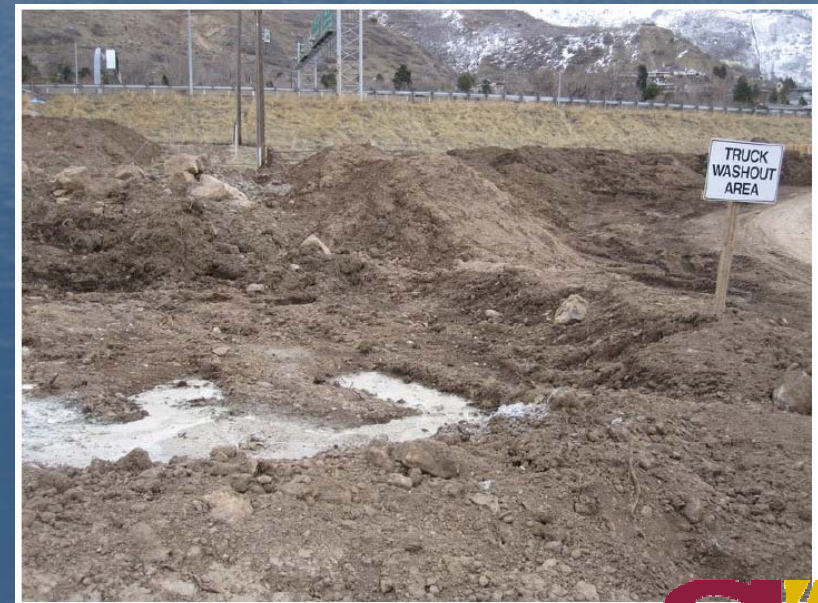
1150
3/6/2012
A. Clark
Fuel tank and fuel
pump at the
Terminal Reservoir
site.

Terminal Reservoir Construction Site
BMPs not noted on SWPPP; concrete washout not lined; spill kit
near fuel tank/spill containment?

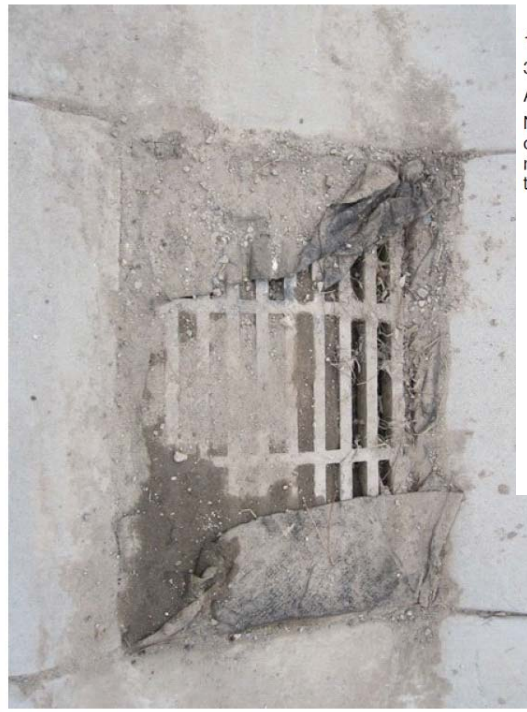
1161
3/6/2012
A. Clark

Close-up of storm drain in photo 1160 at the Arcadia site. Note fabric filter is full of sediment.

Inlet Protection BMPs not properly maintained

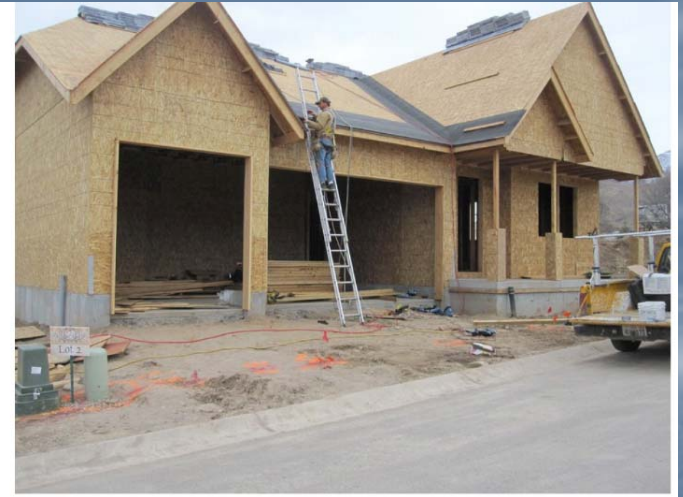
1166
3/6/2012
A. Clark
No BMPs along curb of lot being built north of Fallon Rd. at the Arcadia site.

No perimeter control BMPs along curb

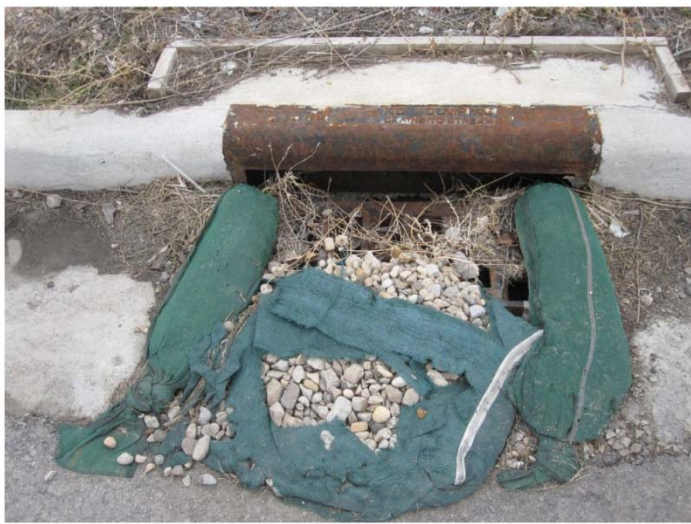
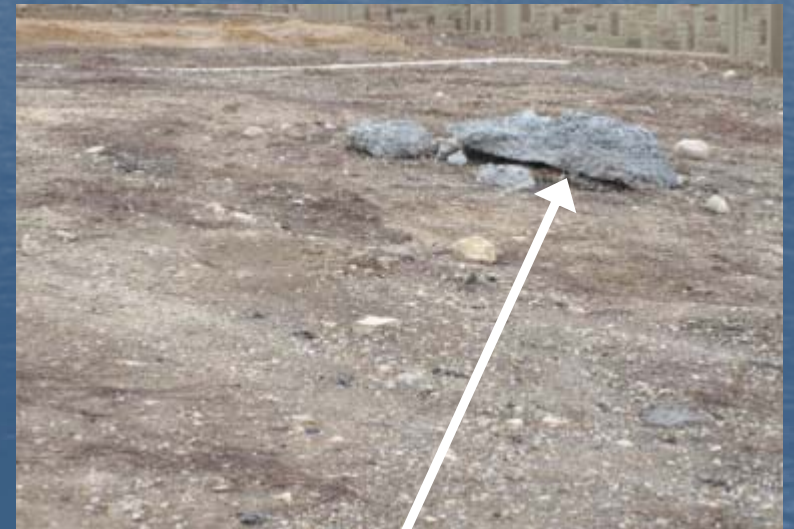
1171
3/6/2012
A. Clark

Storm drain inlet with broken/torn BMPs at Reliance Homes site (North Meadows Subdivision).

Concrete waste

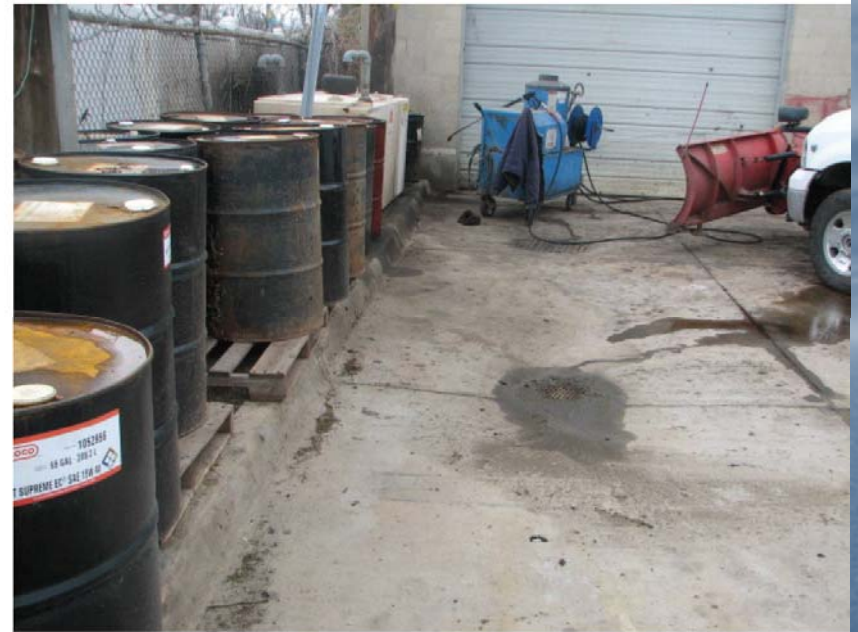
Finding 1ID: Other Good Housekeeping Issues

Photo Number 29
Inspection Date 3/6/2012
Photographer D. Gwisdalla
Description Parks and Recreation EMF. Materials management area; note the movement of the pool of liquid (reportedly gasoline and kerosene) flowing to the storm-drain).

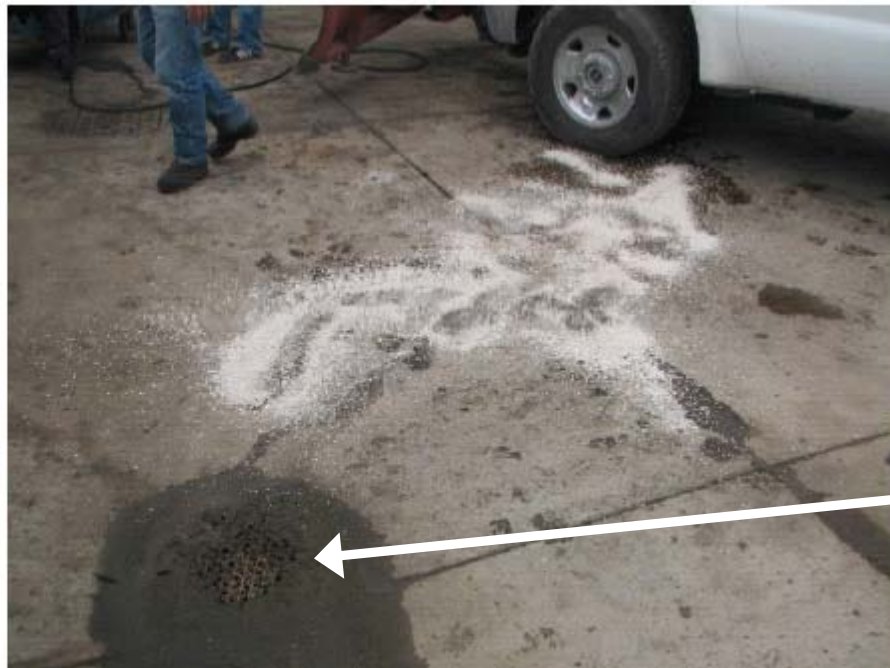
Photo Number 32
Inspection Date 3/6/2012
Photographer D. Gwisdalla
Description Upon the EPA's request, the facility personnel used absorbent material to address the oil and fuel. The storm-drain shown in the bottom left was reportedly connected to separator. It was unclear to staff if the drain was connected to storm or sanitary.

Drain to OWS to SD

Corrective Actions:
Wash Bay was discontinued and replaced by wash bay that drained to Sanitary Sewer System.

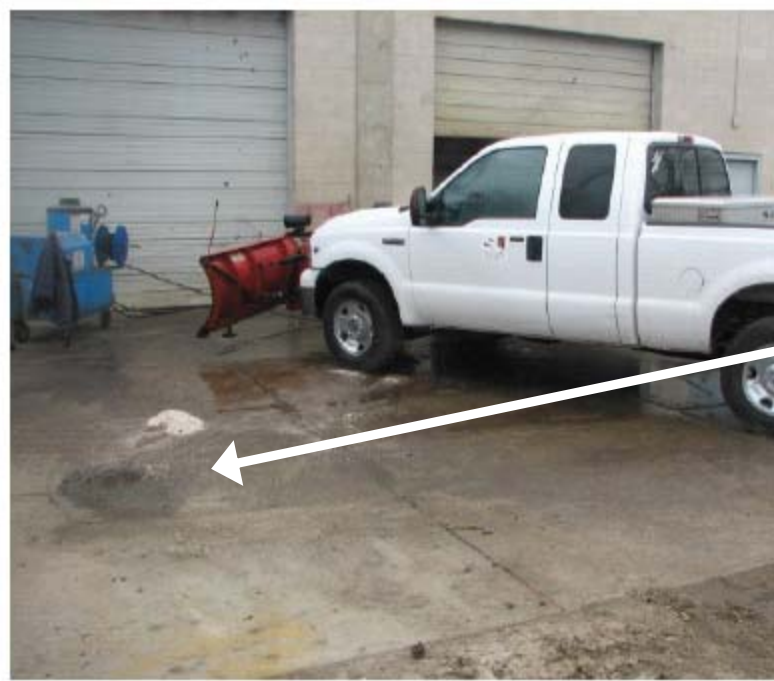
Photo Number 35
Inspection Date 3/6/2012
Photographer D. Gwisdalla
Description Parks and Recreation EMF equipment and vehicle wash pad flowing to the same storm-drain used to dispose of the oil. The photos is of a vehicle being washed with a Hotsy power-washer. The dry absorbent was not cleaned up prior to cleaning the vehicle.

Finding 1ID –
Illicit Discharge
from Municipal
Facility
Operations

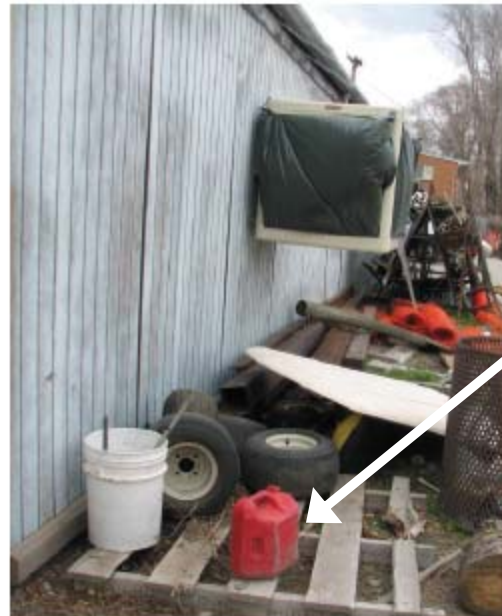
Photo Number 36
Inspection Date 3/6/2012
Photographer D. Gwisdalla
Description Parks and Recreation EMF. Fuel can behind another maintenance garage; note the top is off the container.

Open Fuel Can

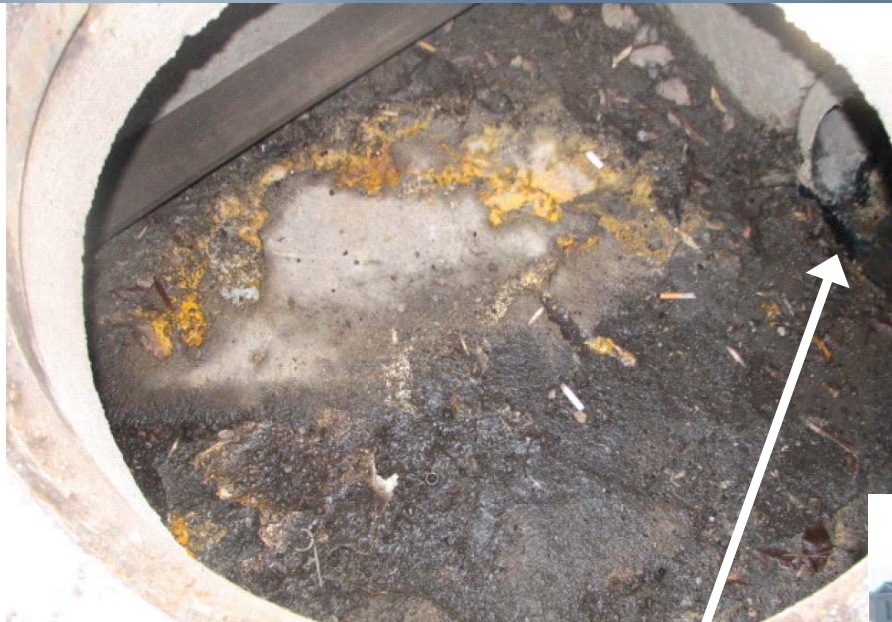
113

Parks and Recreation EMF.
Interior of storm drain shown in photo 52. It was initially believed that the oil-water separator discharge went to this storm drain inlet; that was found to be incorrect. Note the sediment, debris, and paint inside the inlet.

SD Manhole not cleaned/maintained

Follow up- OWS was dye tested and found connected to SD

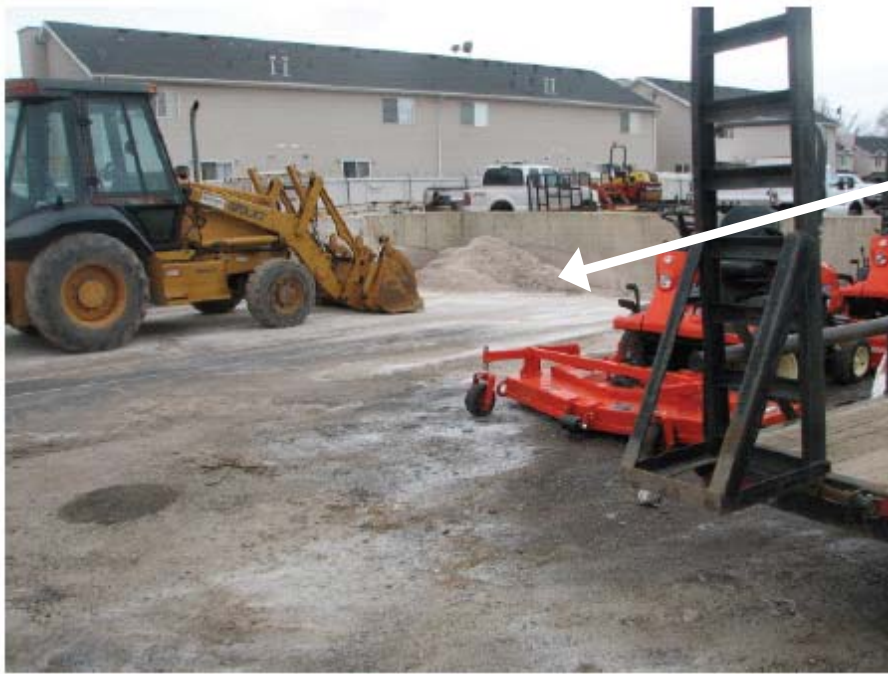
44

Parks and Recreation EMF.
Salt storage pile runoff flow path as shown by salt staining on the soil. Location is on the rear of the property on the northeast side.

Salt Pile

- Salt Pile was removed and discontinued until covered salt storage shed was built

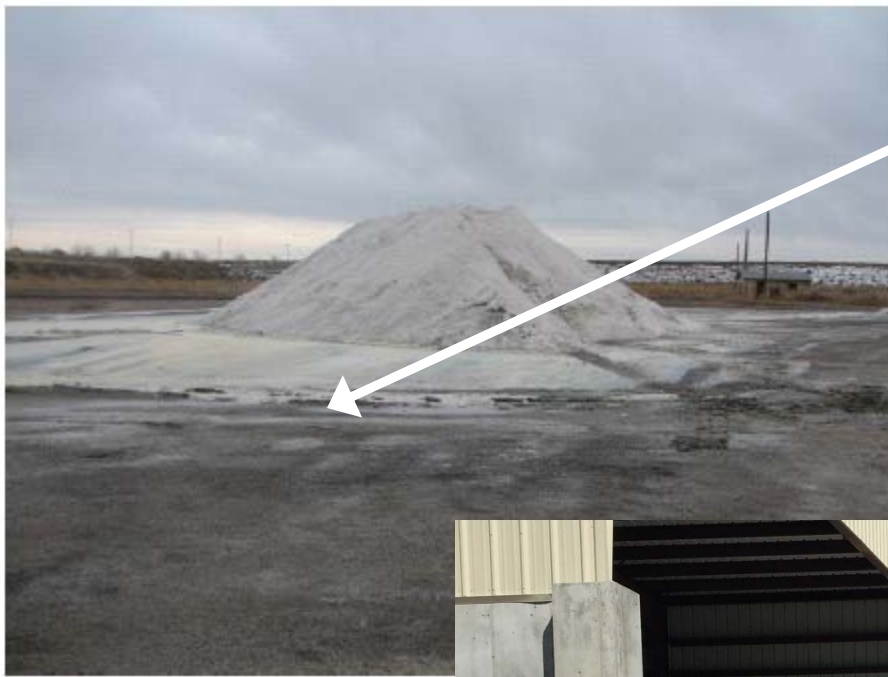
8

Welby MSA Salt
storage pile with
runoff flowing to
Pond 1.

Salt run-off

If salt pile is not
covered,
Must have adequate
run-off storage and
containment

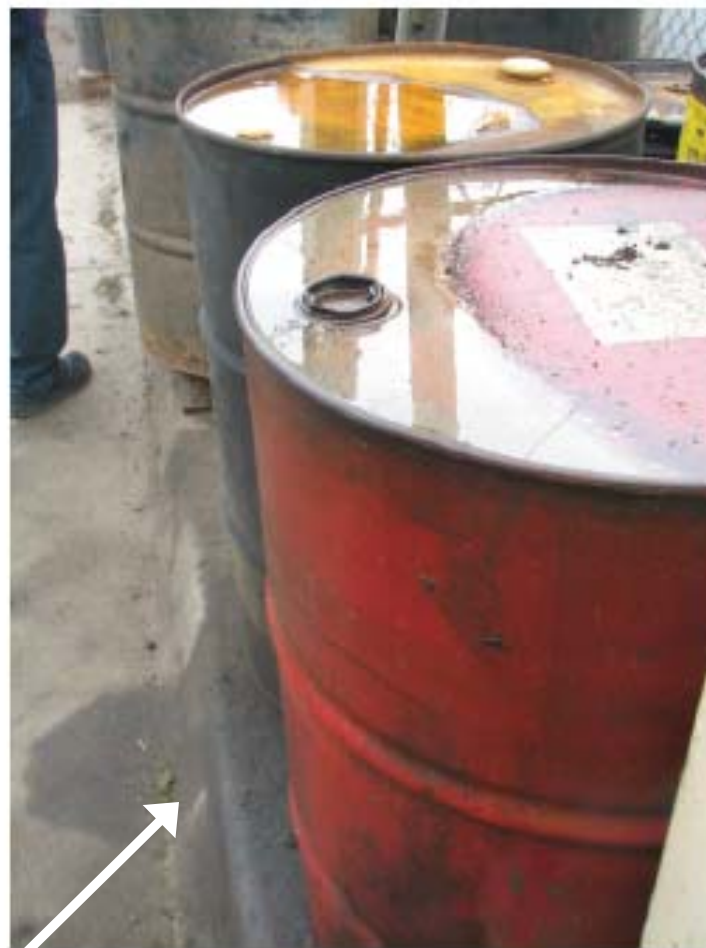
Photo Number 31
Inspection Date 3/6/2012
Photographer D. Gwisdalla
Description Parks and Recreation EMF. Close-up of the material on top of the red drum. The black drum to the rear also had liquid on it. Note the staining on the ground in front of the storage area.

Staining

Trash and other bins must be closed and plugged

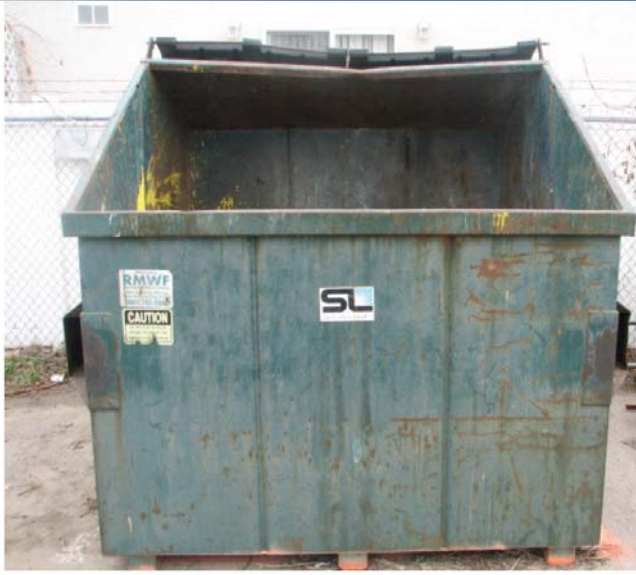
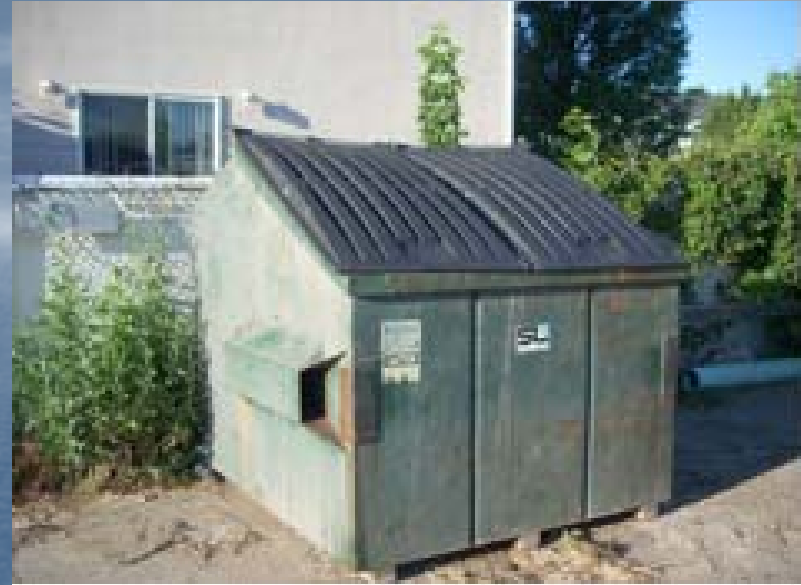
No Plug

3/6/2012
D. Gwisdalla
Parks and
Recreation EMF.
Dumpster located at
the site, note the
dumpster lid was
open during the
inspection.

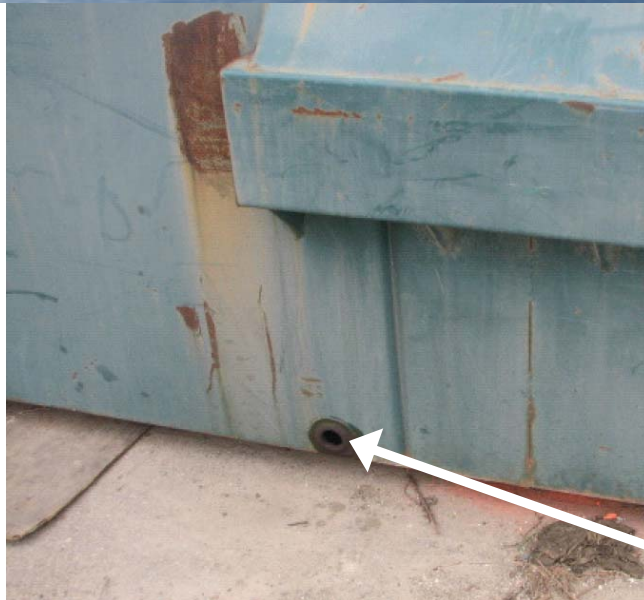
3/6/2012
D. Gwisdalla
Parks and
Recreation EMF.
Dumpster located at
the site the outlet
shown in photo 50 is
shown on the outside
of the dumpster.

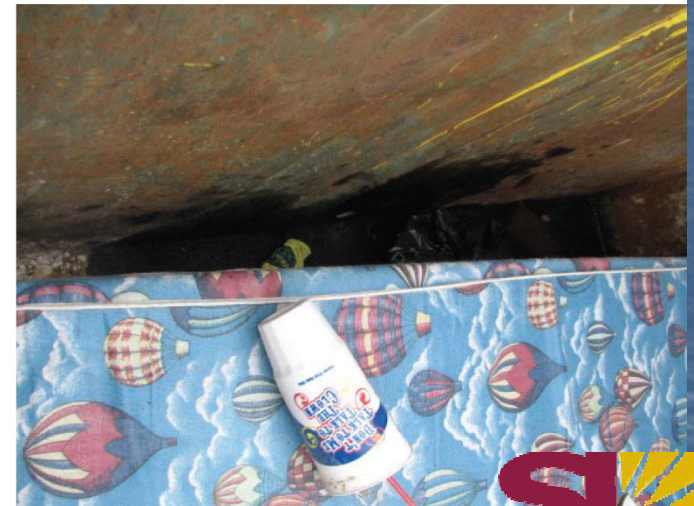
3/6/2012
D. Gwisdalla
Parks and
Recreation EMF.
Dumpster located at
the site shown in
photo 49, note what
appears to be oil
staining inside the
dumpster. The outlet
is shown in the photo
in the center just
above the balloon
patterned waste.

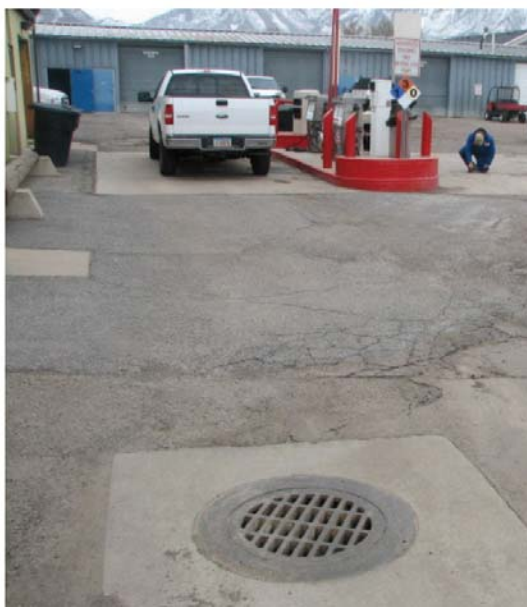
52

Parks and Recreation EMF.
Fueling facility; note the storm drain serving the fueling area.

A spill kit was placed and spills were cleaned

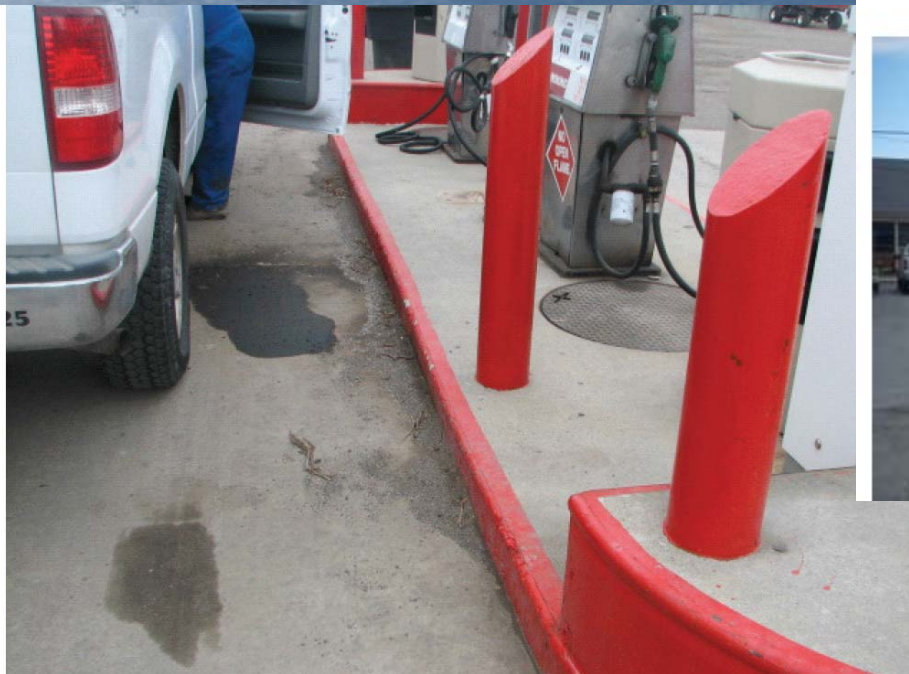
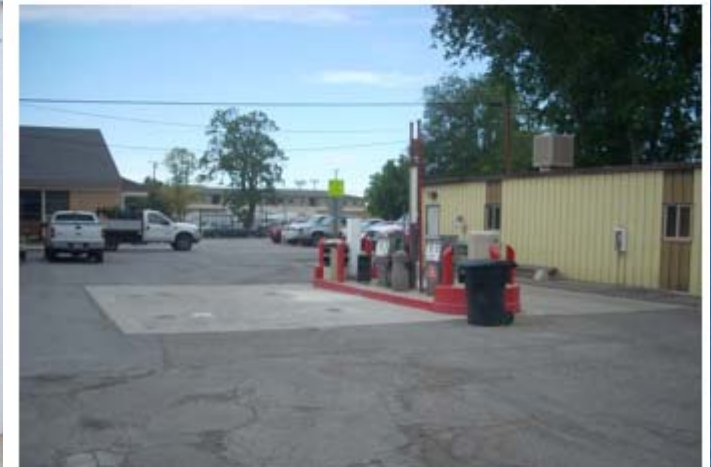
53

Parks and Recreation EMF.
Fuel spillage at the fueling station. No spill containment or response equipment was noted at the site. The spill was not addressed during the EPA's inspection by site personnel.

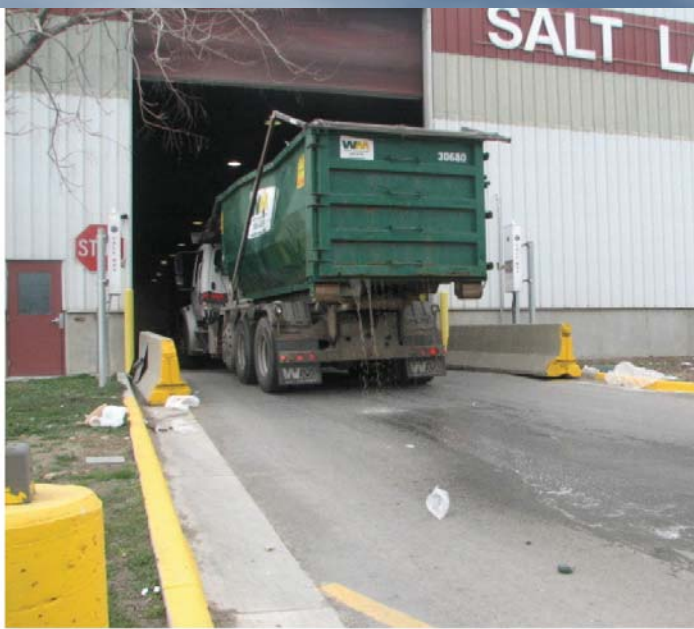
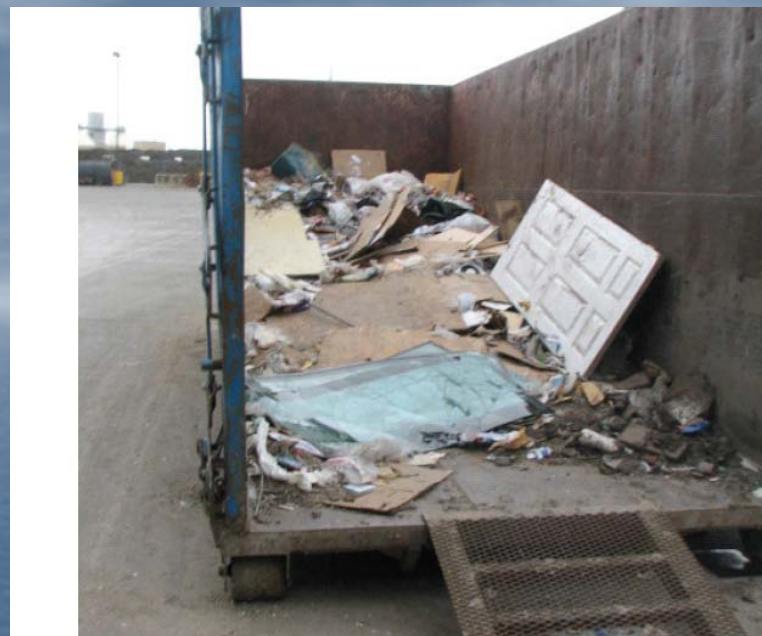
61

Salt Lake Waste
Transfer Station.
Dumpster being
brought into the
facility discharging
liquid.

Trash not contained,
liquid leaking from
dumpster

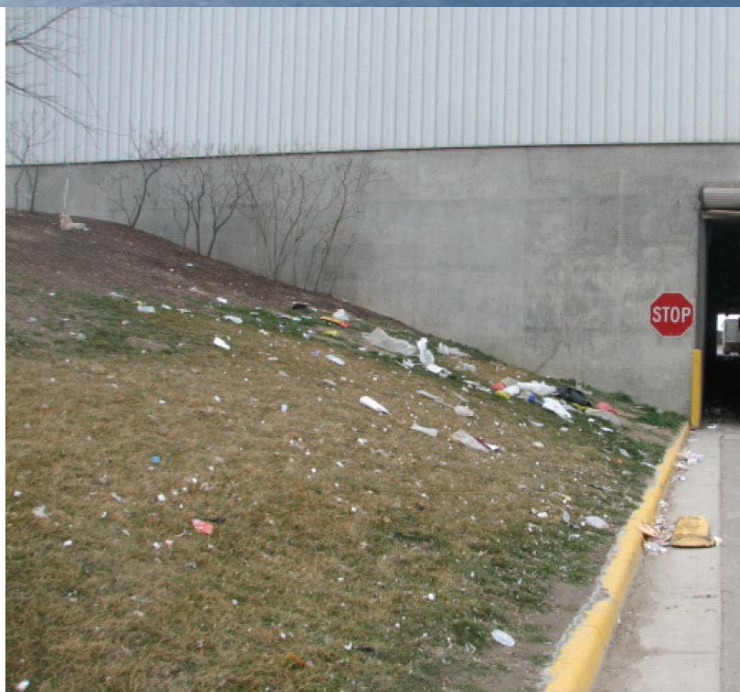
63

Salt Lake Waste
Transfer Station.
Note the trash
outside the facility.

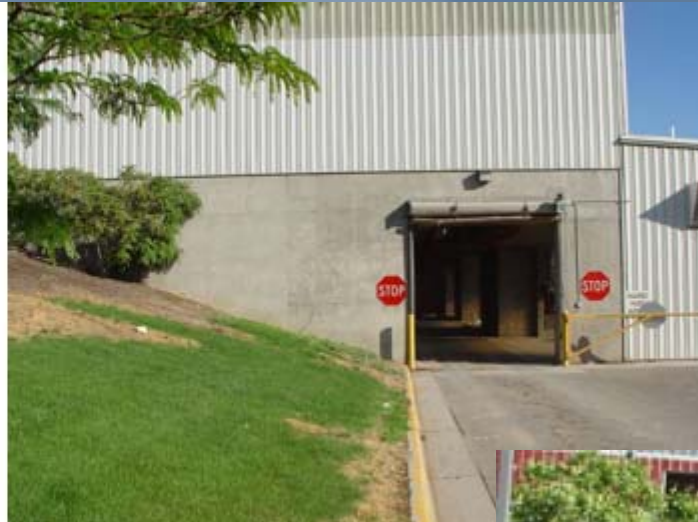
Reference EPA Photo Number 63
SLCo Photo 7/20/12

Windblown litter picked up on grassy hillside.
Litter is picked up daily by the supervised
"trustee" crew from the County jail.

Trash is properly contained and
picked-up, no leaking from dumpster

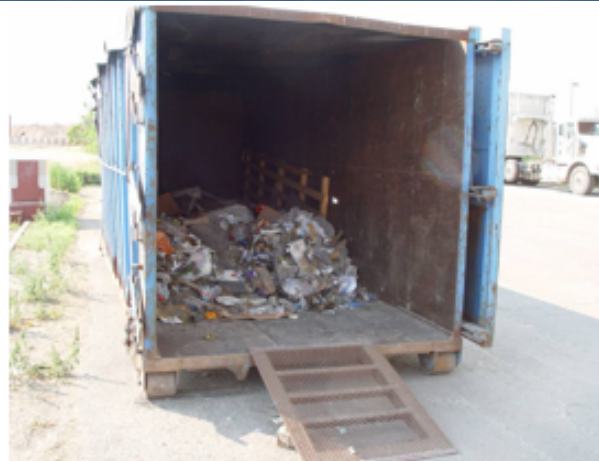
Reference EPA Photo Number 65
SLCo Photo 8/8/12

Picture shows tarping on "trustee" container to
control windblown litter and it has been positioned
to minimize windblown litter.

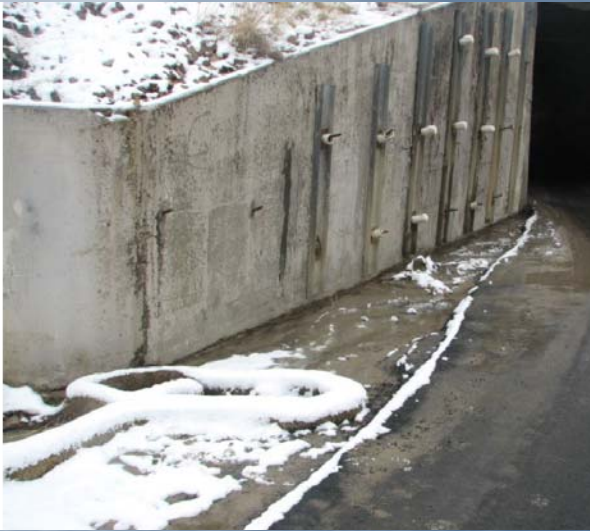
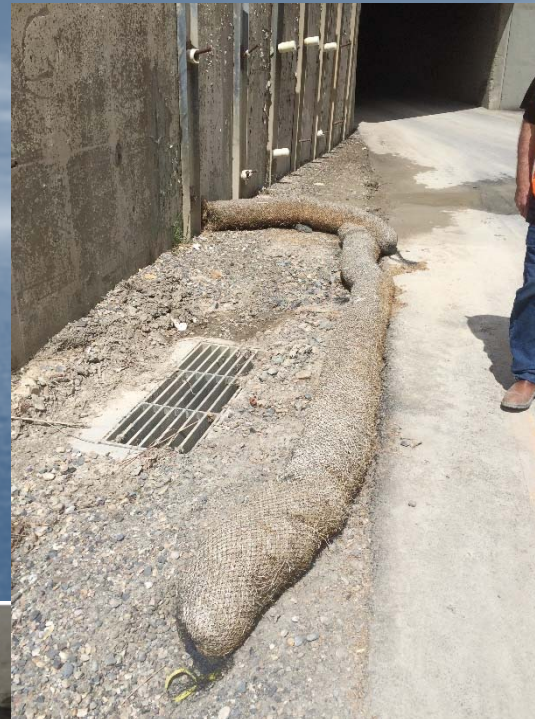
103

Harper/Kilgore Pit 16 - Second view of the I-80 underpass from the south side. A straw waddle and storm drain inlet are on the bottom left. Note the sediment along the left side of the road.

This gravel pit is a high priority industrial site that is inspected annually

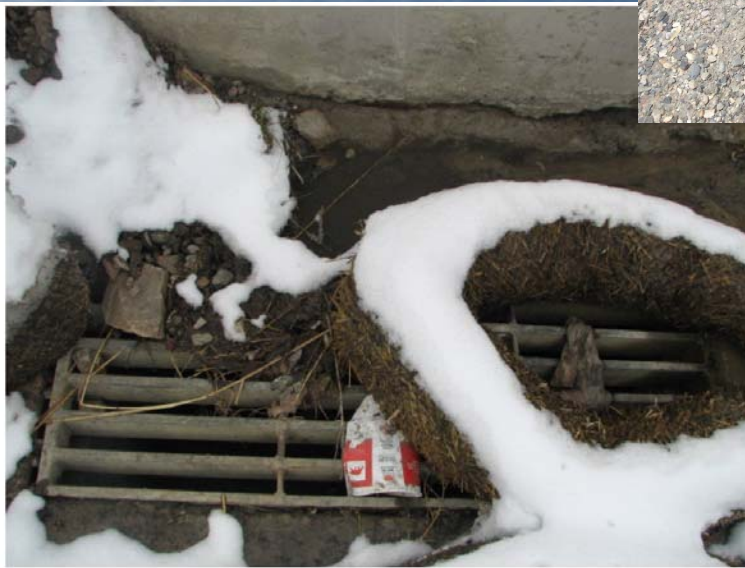
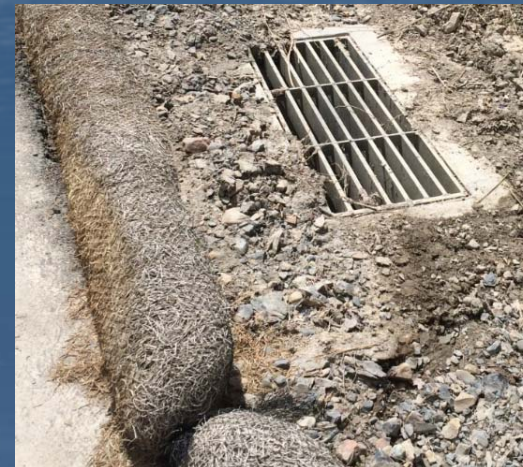
105

Harper/Kilgore Pit 16 - Second close-up view of the storm drain inlet and straw waddle in photo 103. Note the sediment on top of and around the storm drain.

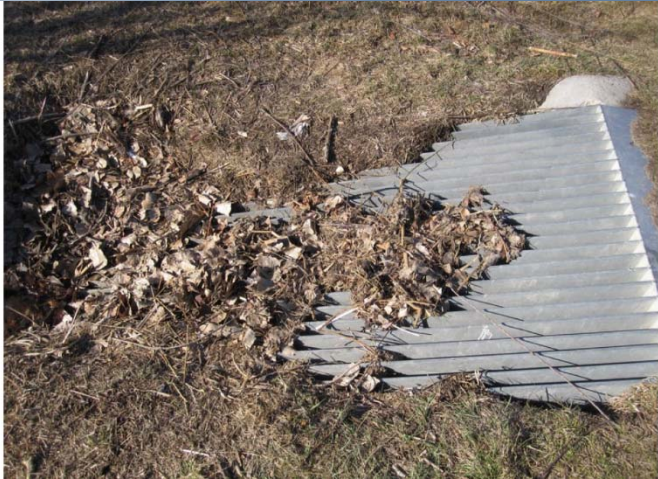
1182

Poor Maintenance of stormwater bmps

I-9 detention pond -
Close up of the outlet
grate. Note the
sediment has built up
around the edges of
the grate such that
grass is starting to
grow on the grate.

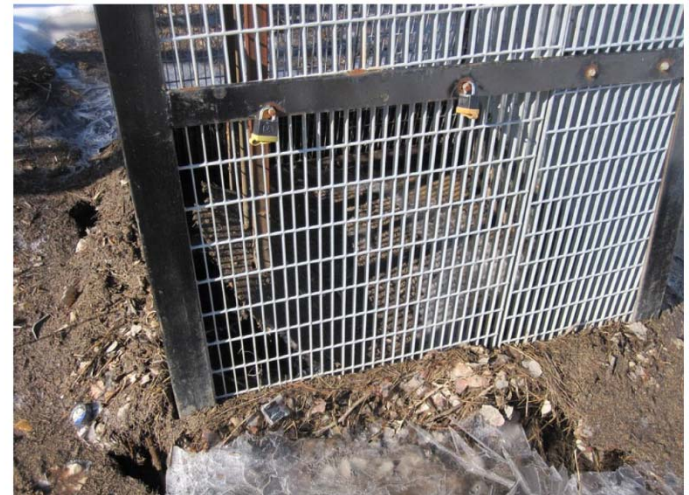
1190

Oaker Shadows
pond - Close up view
of the outlet
structure. Note the
grass built up on the
inside and outside of
the grates.

Municipal and privately owned stormwater controls must be maintained and inspected

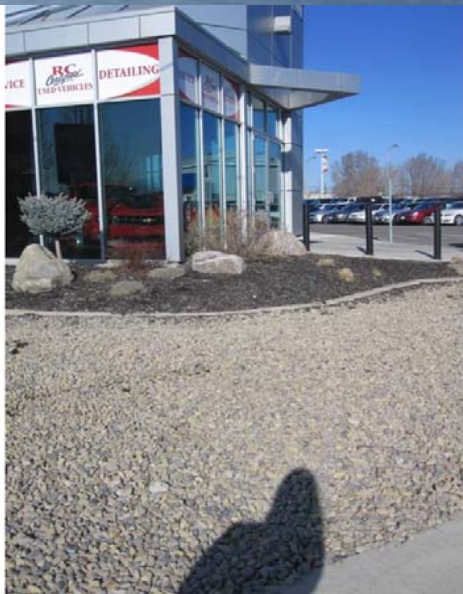
1185

R.C. Automotive -
View of the area
near the northeast
corner of the building
where a baysaver
and orifice plate
were noted on the
plans. There are no
manholes indicating
these are present.

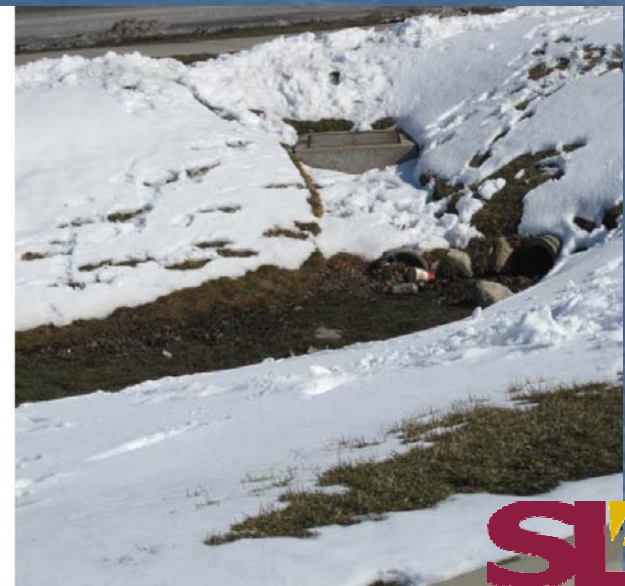
1191

Arbor Development
shopping center -
View of the drainage
inlets along the north
side of the parking
lot that flow to the
detention pond.
Note the sediment
and debris built up
around the pipes.
The pipe on the left
is almost completely
covered.

Stormwater Controls must be maintained as per plan, Annual Inspections
