NATURAL RIVERS, URBAN STREAMS, AND WORKING WATERWAYS – USING CONTEXT TO INFORM RESTORATION

Andrew Earles, Ph.D., P.E., CPESC & Natalie Phares, CFM, HIT
Wright Water Engineers, Inc.
Denver, Colorado

November 16, 2017

International Erosion Control Association
Mountain States Chapter Annual Conference

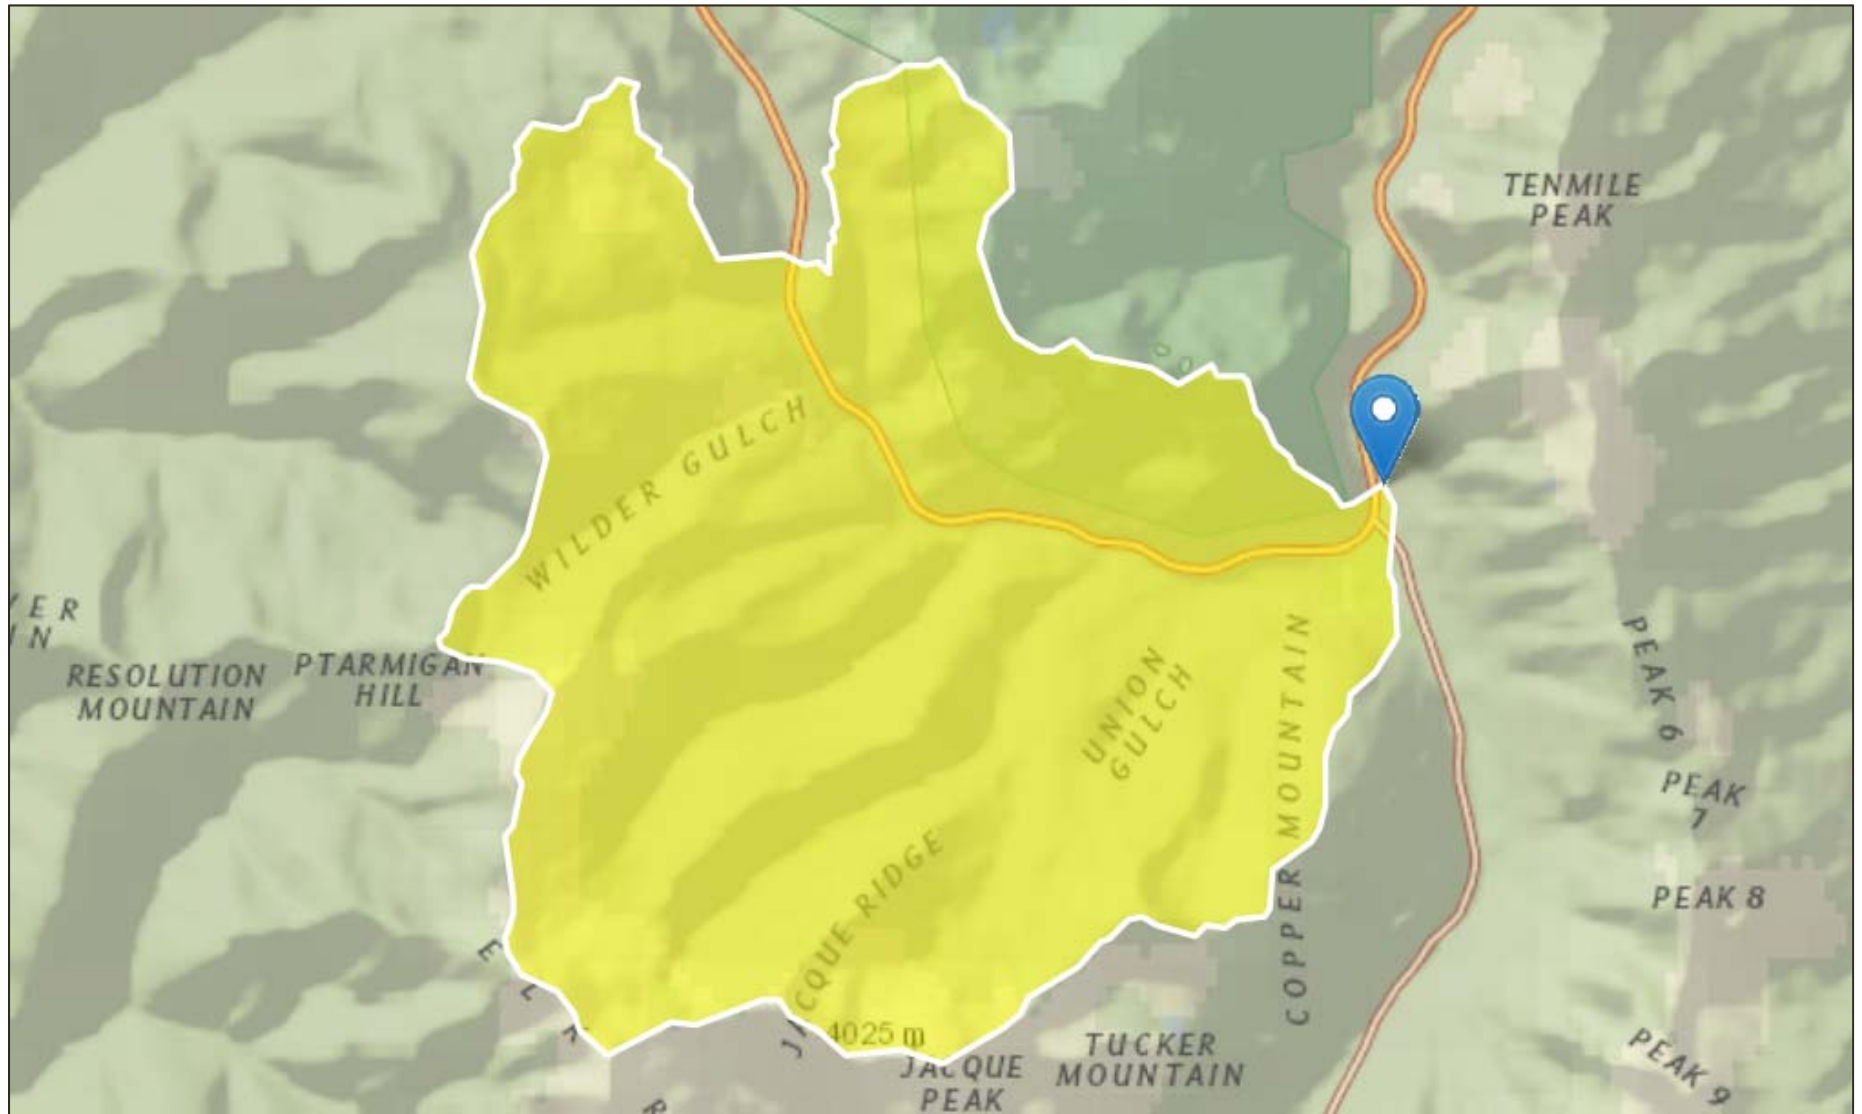
West Tenmile Creek Watershed

- Area = 27.4 square miles
- Mean annual precipitation = 29 inches
- Mean watershed elevation = 11,100 feet
- 100-year 24-hour precipitation = 3.3 inches
- 2-year 24-hour precipitation = 1.4 inches
- Percentage of clay soils ~ 17%
- Time of concentration ~ 1 hour
- Very little development in watershed

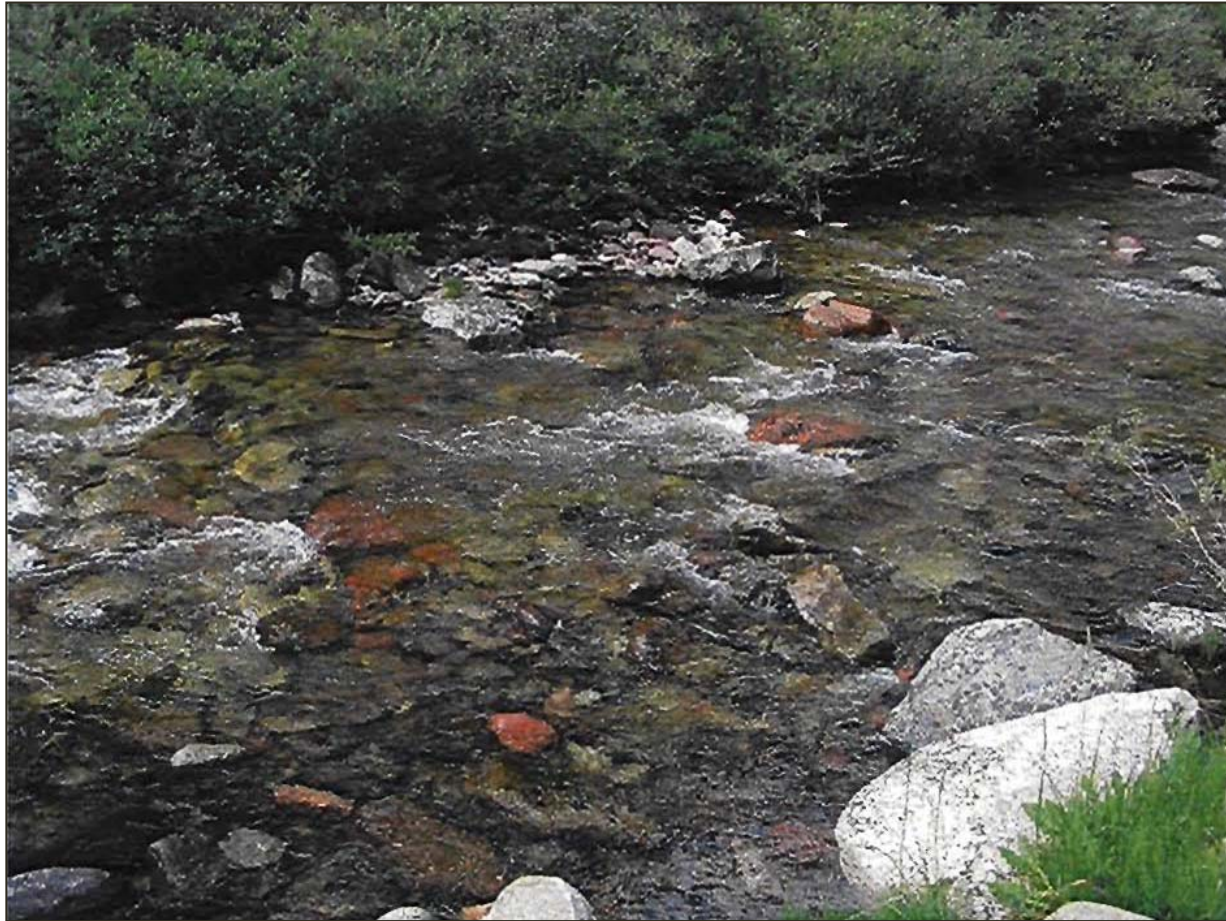
Typical Streambed Conditions

- Well armored channel with cobble to boulder sized bed material
- Very resistant to erosion from typical flows
- Good substrate for macroinvertebrates

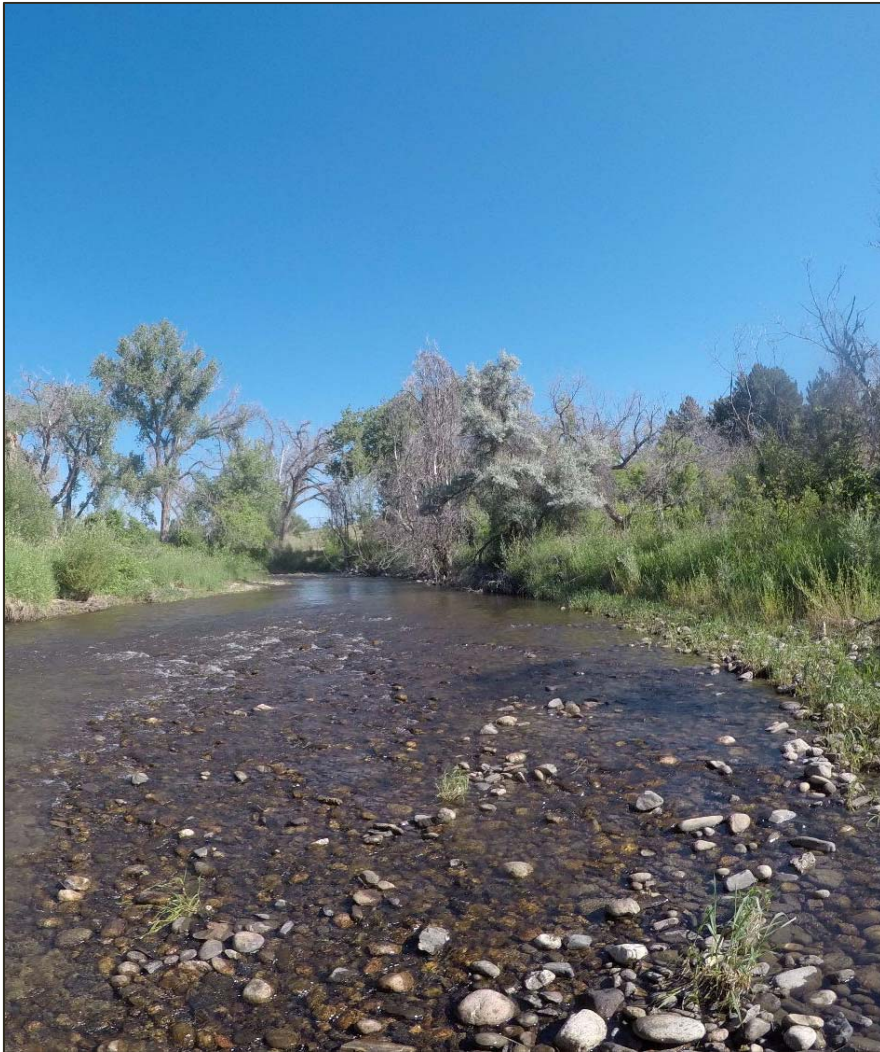
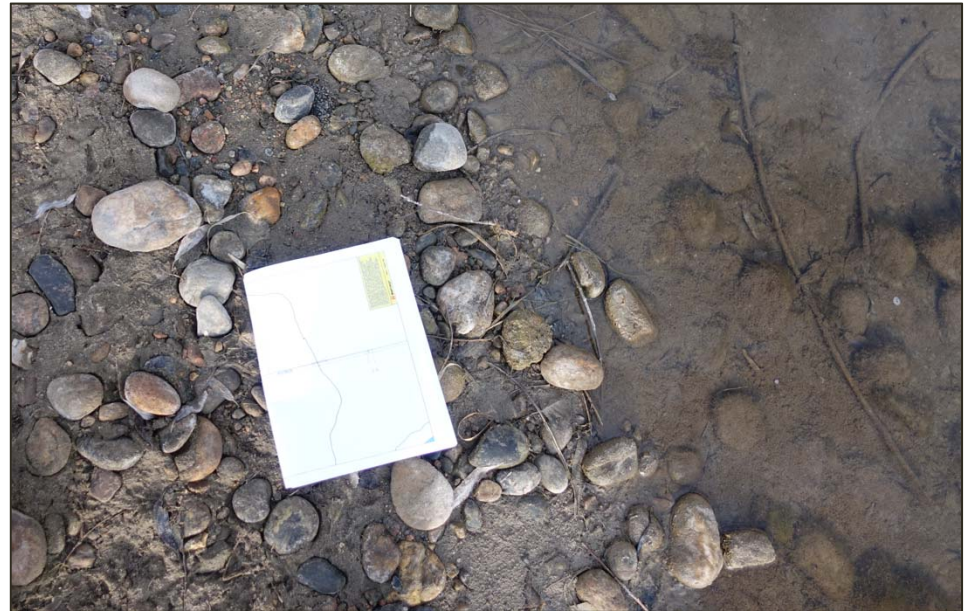
Typical Streambed Conditions

- Cobble bed in upper reaches through Loveland
- Transitions to gravel and silt bed in lower reaches through City
- Significant scour in 2013 flood but little day-to-day erosion of bed or banks

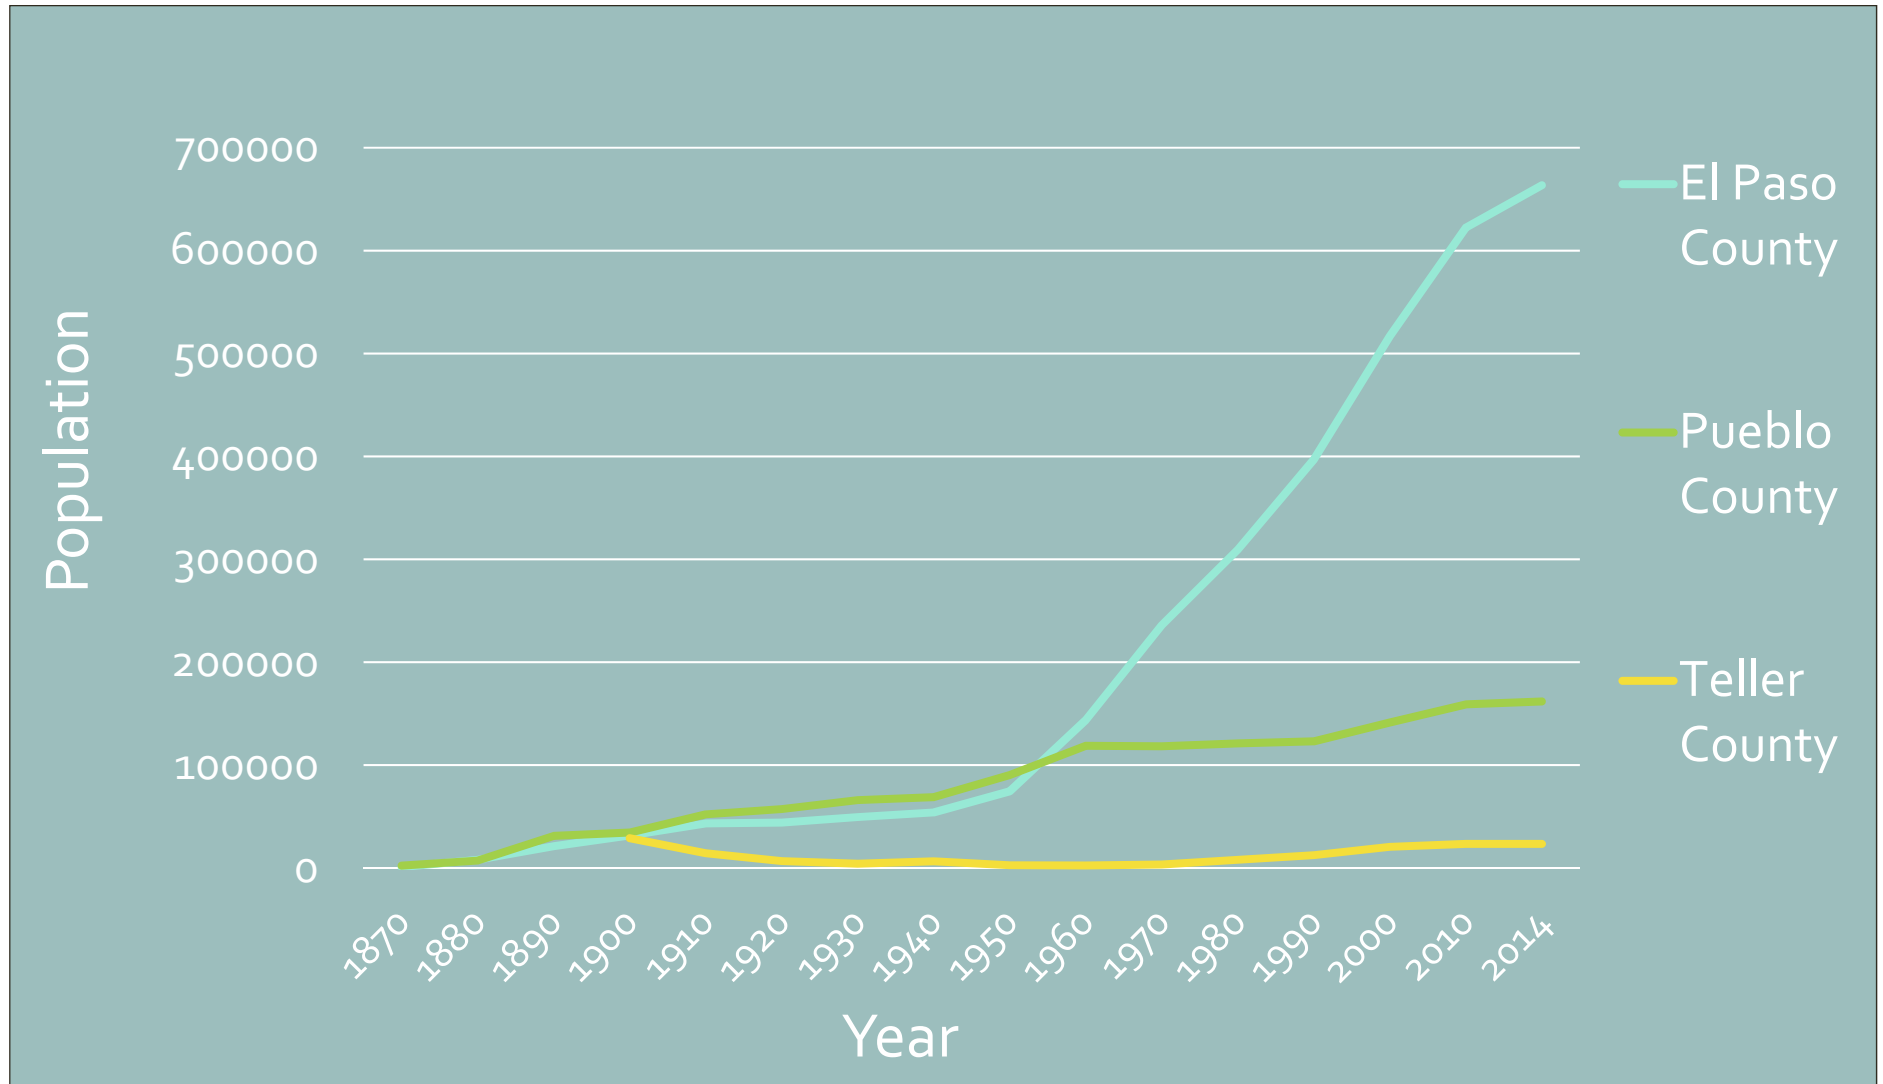
Population of El Paso, Pueblo, and Teller Counties, 1870–2010, with projected year 2014 population (U.S. Decennial Census)

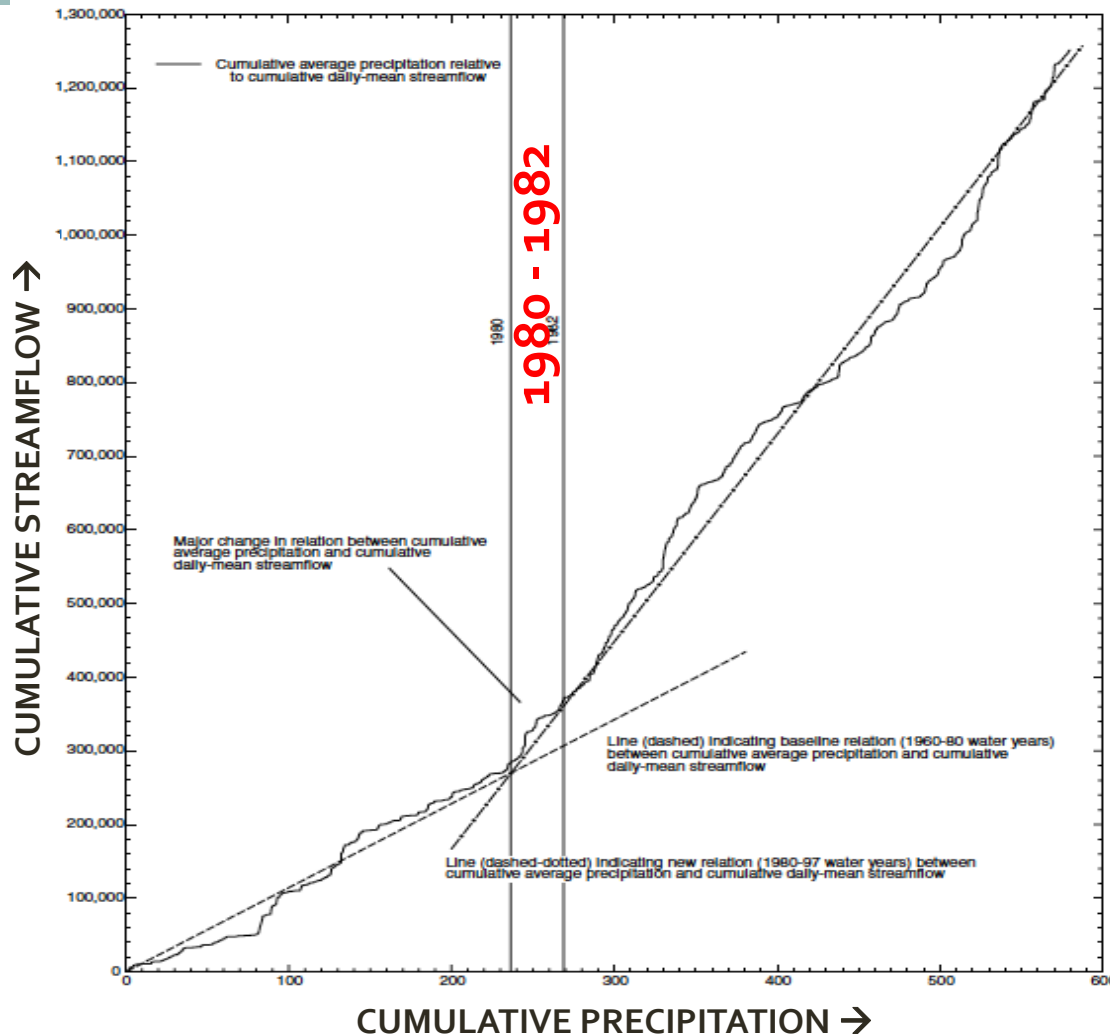
Shift in Rainfall-Runoff Response c. 1980 (USGS 2000)

Plausible reasons for changes:

- Importation of transbasin water from outside the watershed;
- Sparse spatial distribution of precipitation stations
- Changes in land use within the watershed could have altered the hydrologic response of the watershed to precipitation events; or
- Changes are due to combination of these variables (Stogner 2000).

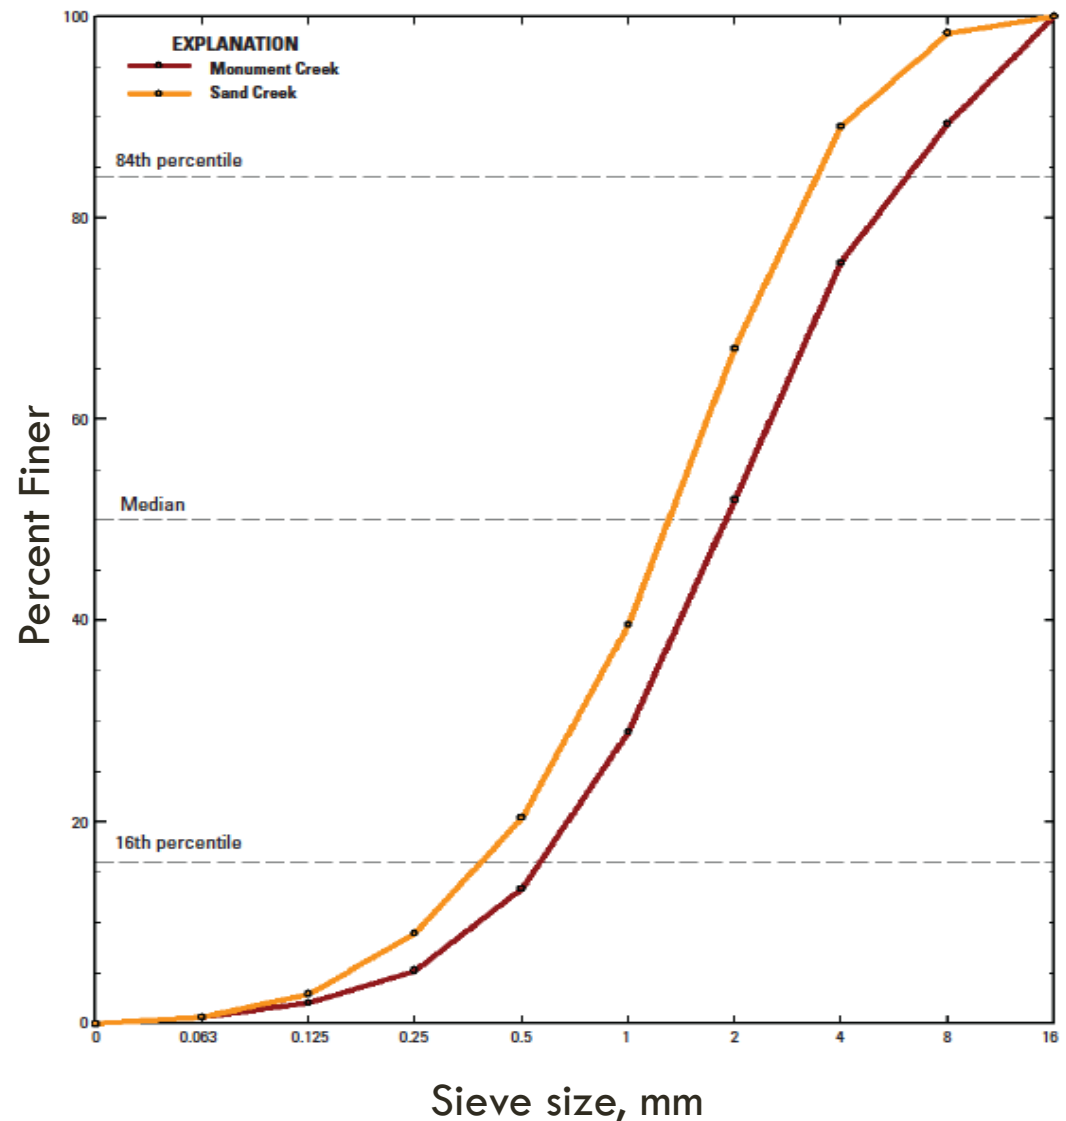
Monument Creek & Sand Creek Bed Material (USGS, 2007)

Minimum streamflows in Fountain Creek and its tributaries have the capacity to transport sand-size particles.

Higher streamflows ranging from 0.28 cubic meters per second (m^3/s) [9.9 cfs] to 17 m^3/s [600 cfs] have capacity to transport gravel-size particles (Mau and others, 2007)

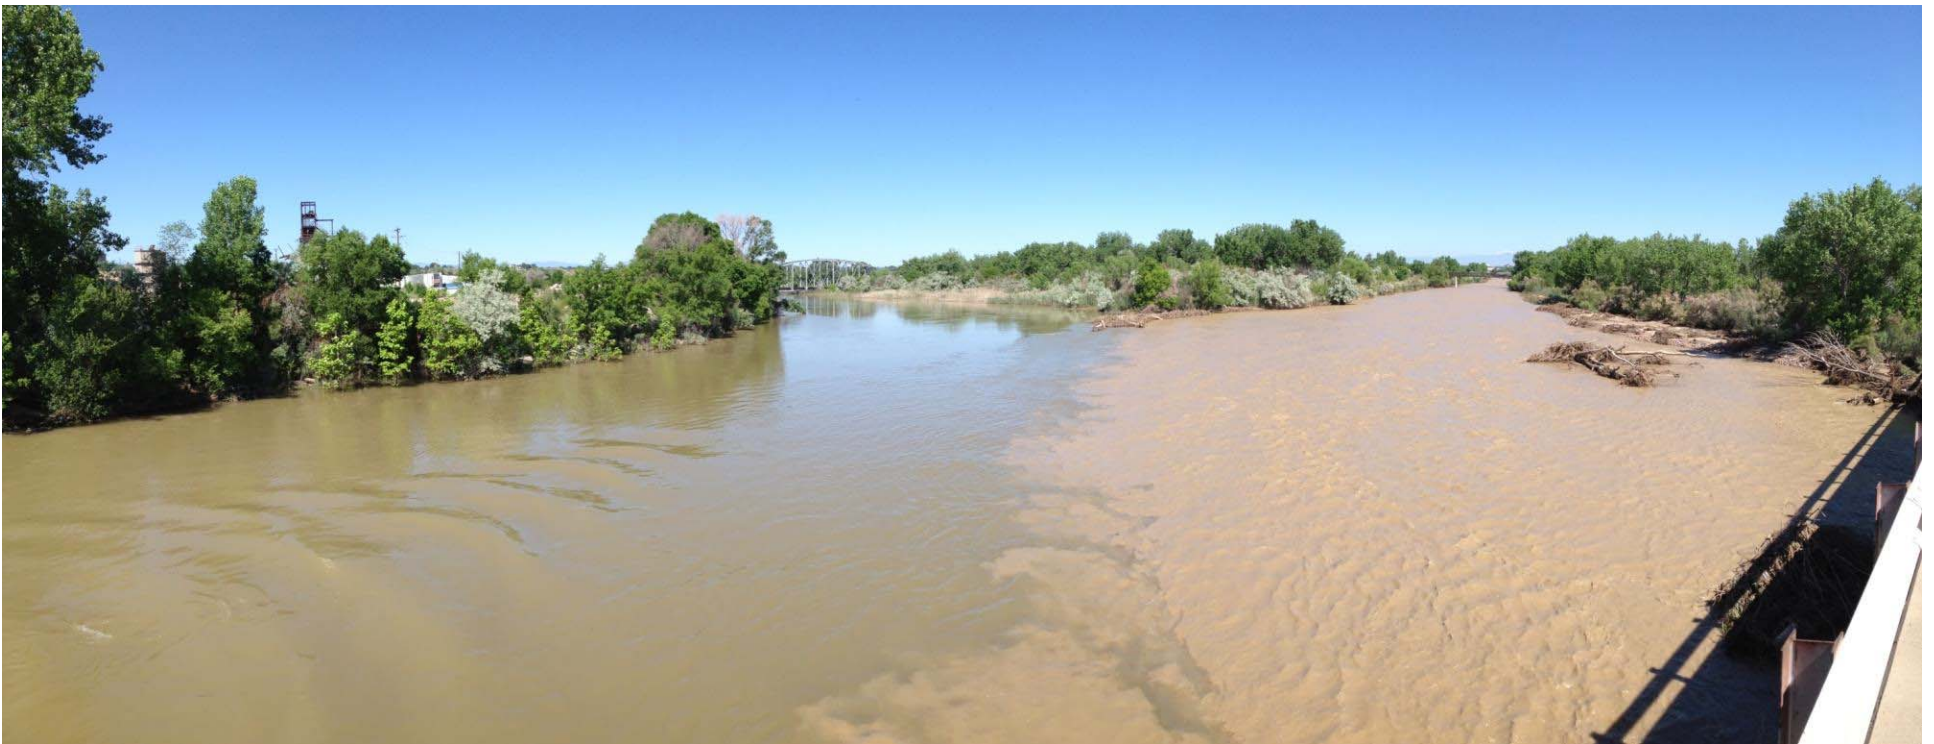
Effects of Altered Hydrologic and Sediment Transport Regimes

Confluence — Arkansas River (on left) and Fountain Creek (on right)
