**COLORADO**  
Department of Transportation  
Region 5

# 416 Fire – Restoration Lessons Learned

**Protecting Highway Infrastructure from Sediment  
Run Off Due to Large Scale Burns**

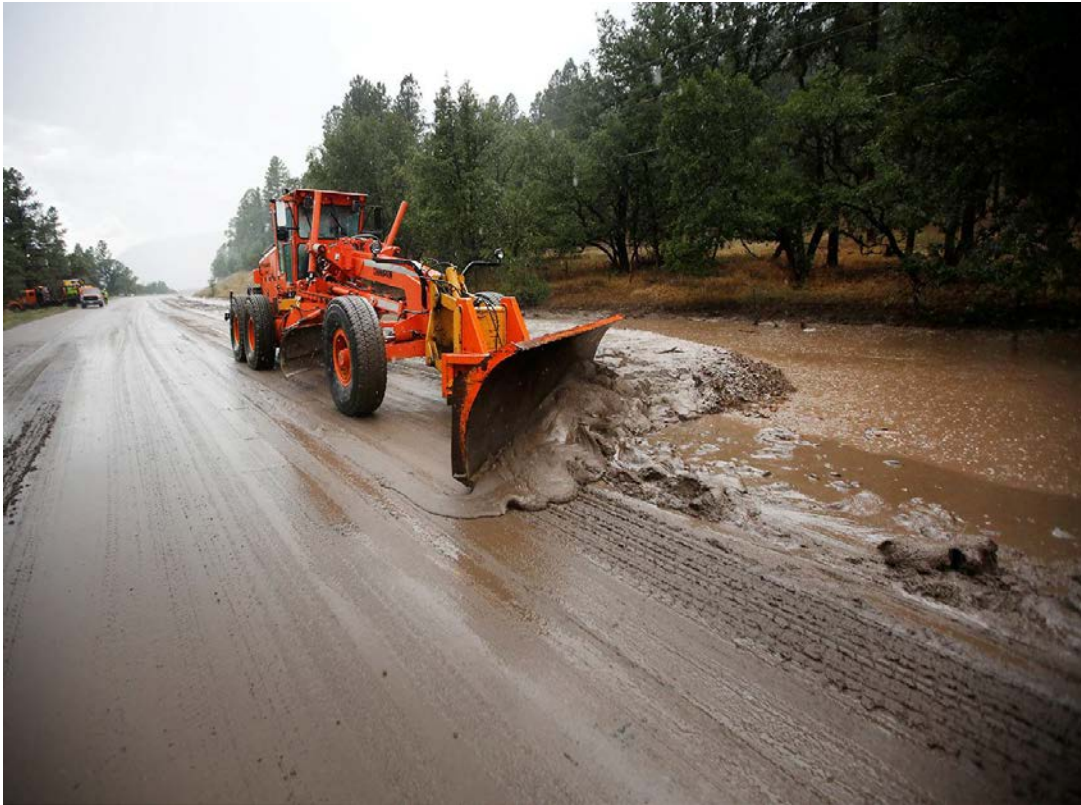
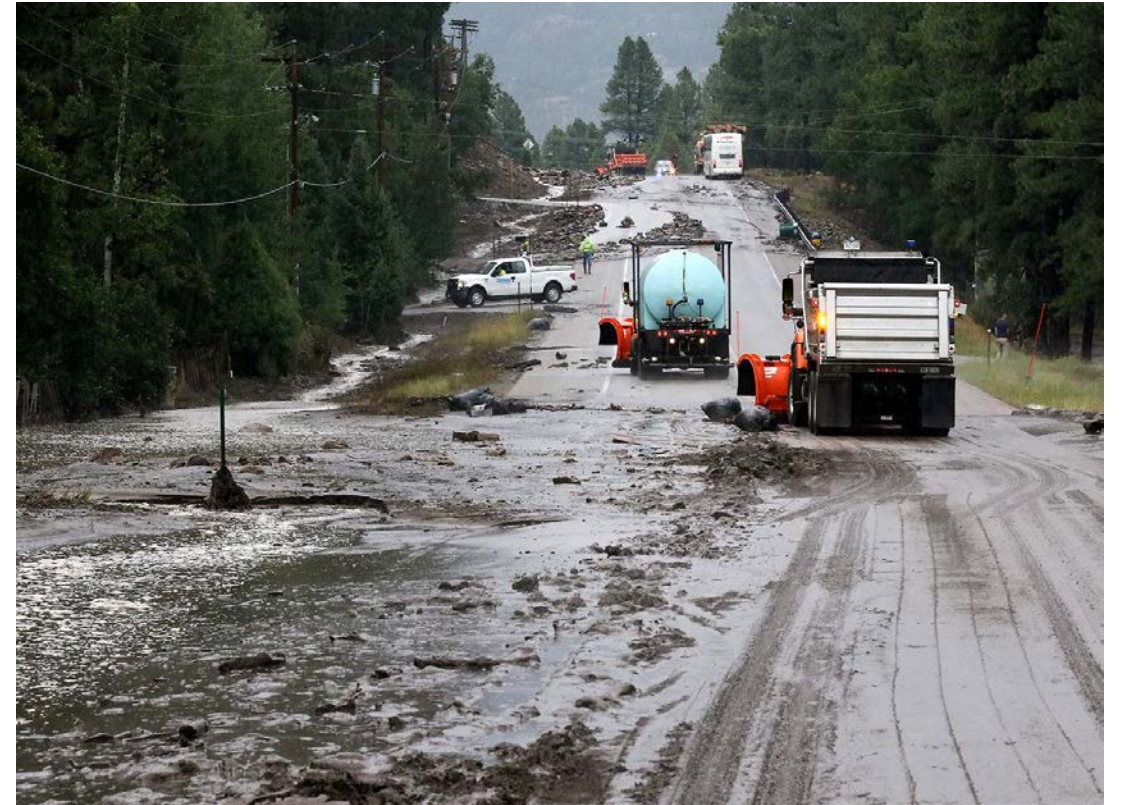
# US Highway 550 – Debris Flow from 416 Fire

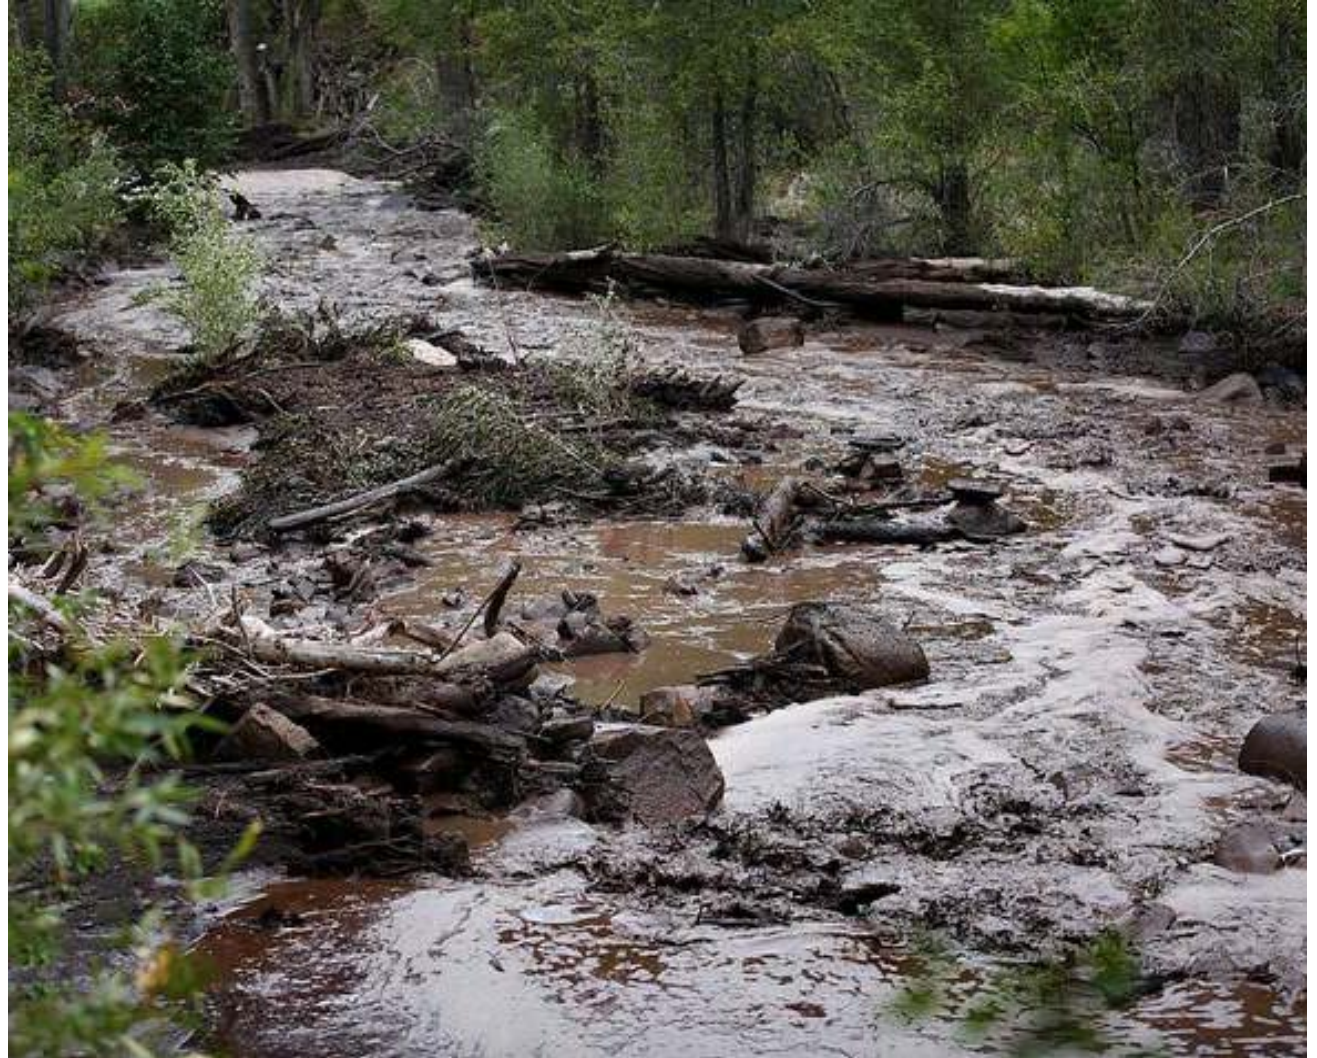
# Post-Fire Hazards

- Sediment Load Increase
- Runoff volume and rates can double
- Location of events can be unpredictable
- Events can be hydrologic, geotechnical or geomorphic

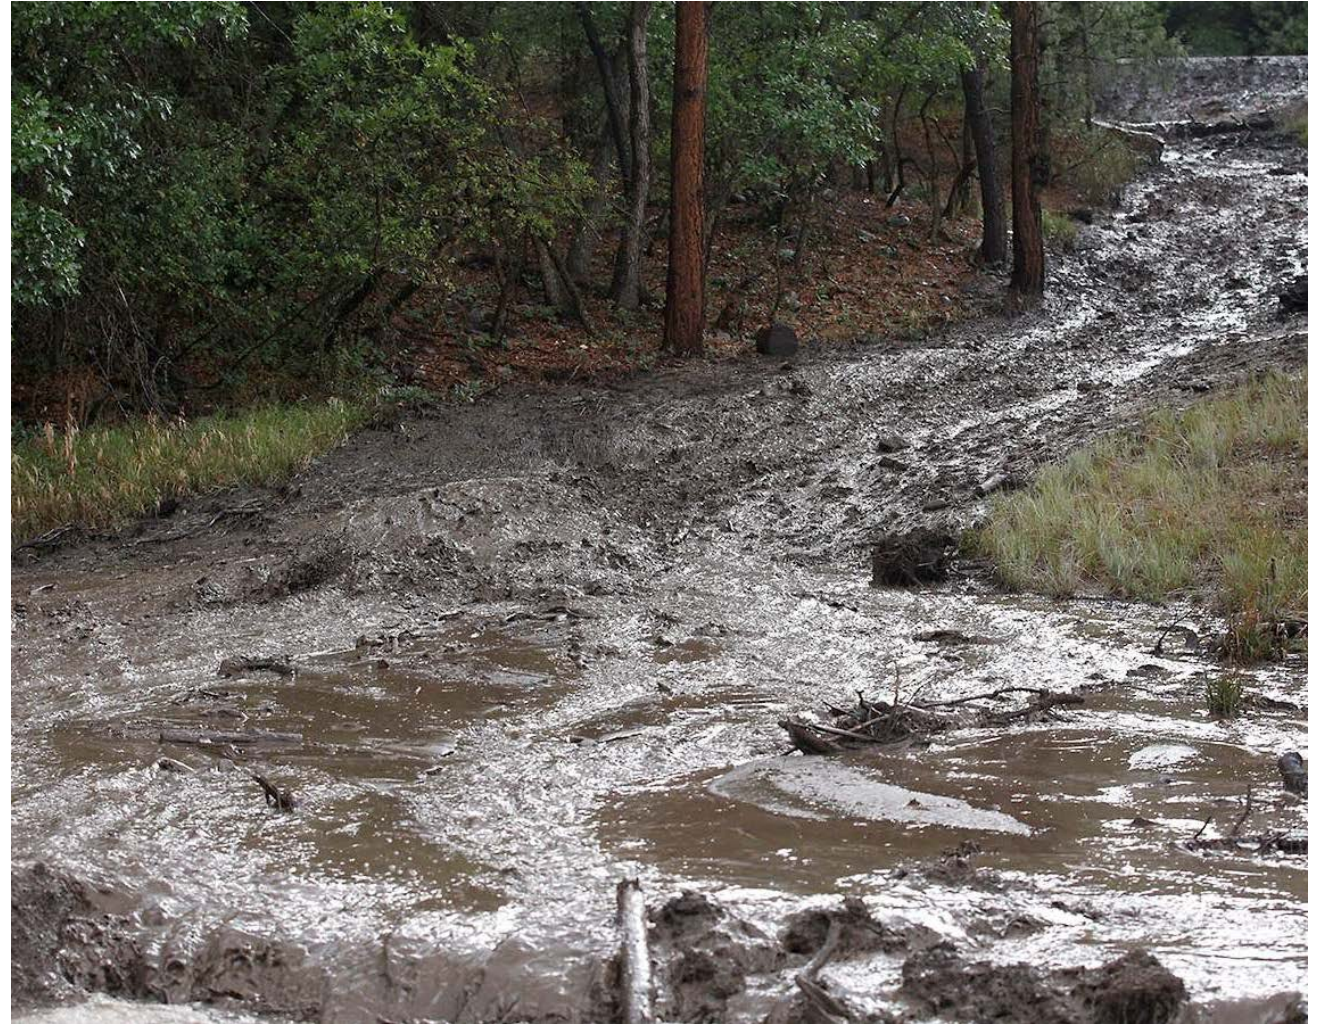
# Issues Identified on US HWY 550

- Debris Flow
- Drainage ditches full of Sediment
- Slope Erosion and Wash Out
- Mud/Rock Slides over Roads
- Plugged Culverts
- Flooding

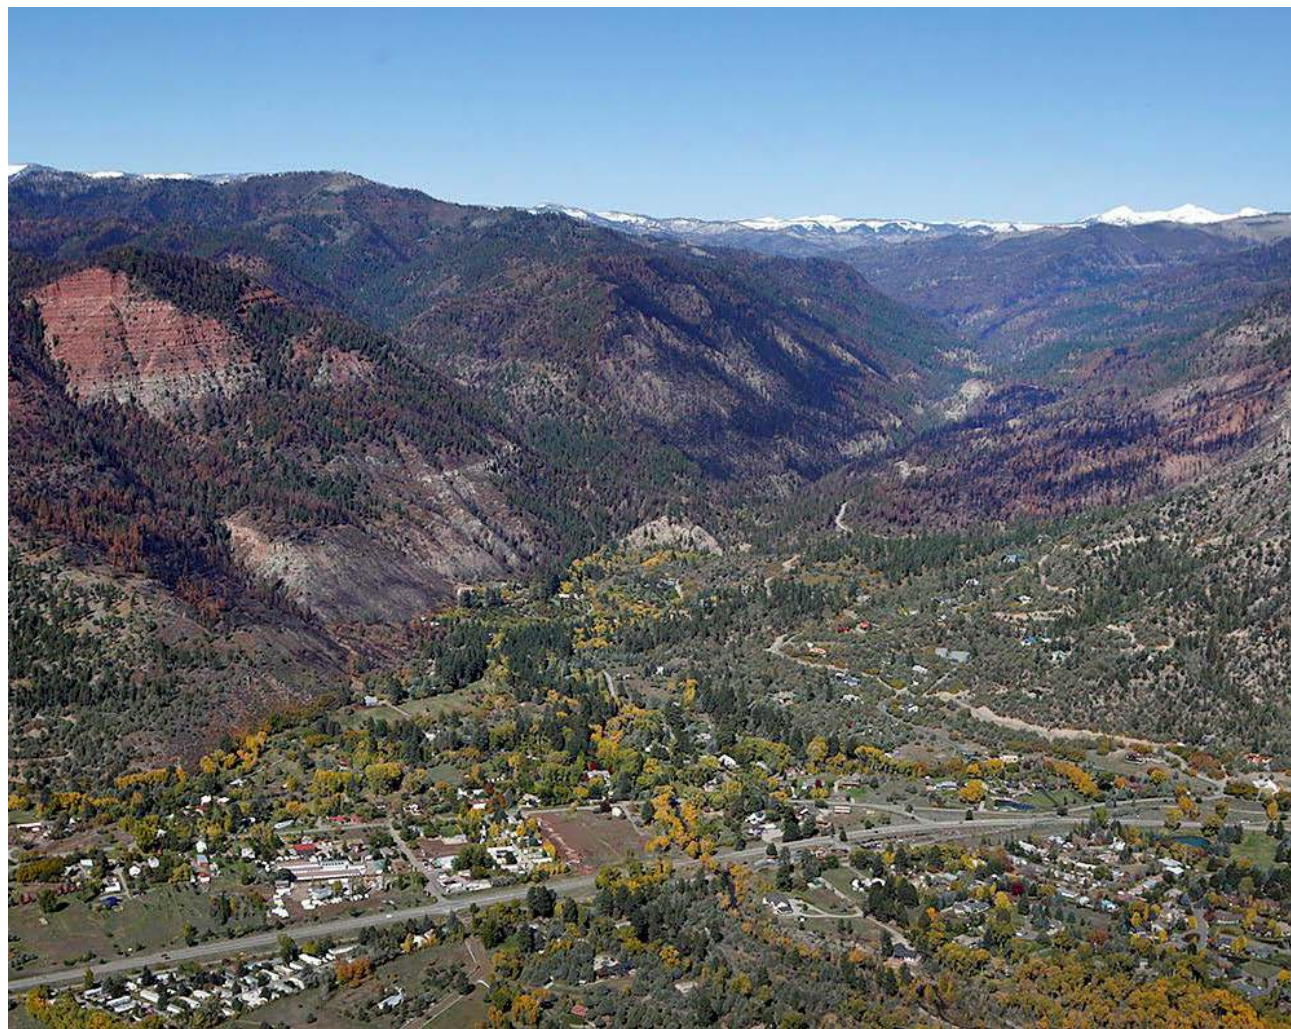
# PLANNING AHEAD

- Identify hazards and mitigate quickly to protect public safety and infrastructure
- BAER Team developed a plan and identified high risk areas
- CDOT MTCE was quick to respond to emergency situations and cleaned debris as necessary

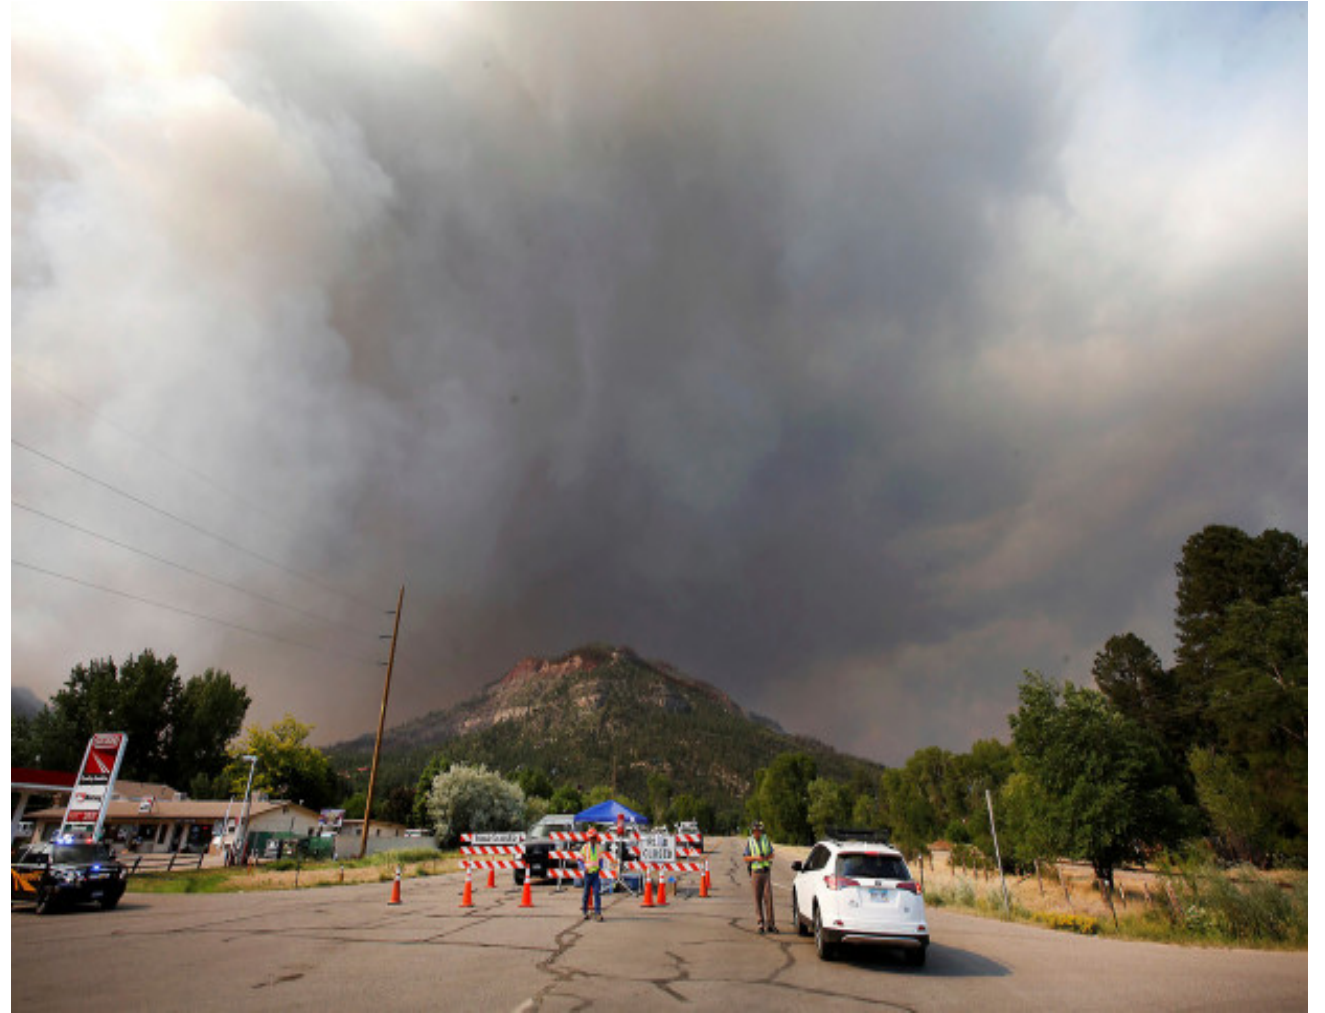
# PLANNING AHEAD

- Designed low-cost, effective control measures and seed plan
- Clean highway, clean culverts, remove debris, utilize debris as control measures
- Collaborate with adjacent land owners
- Select or design Control Measures

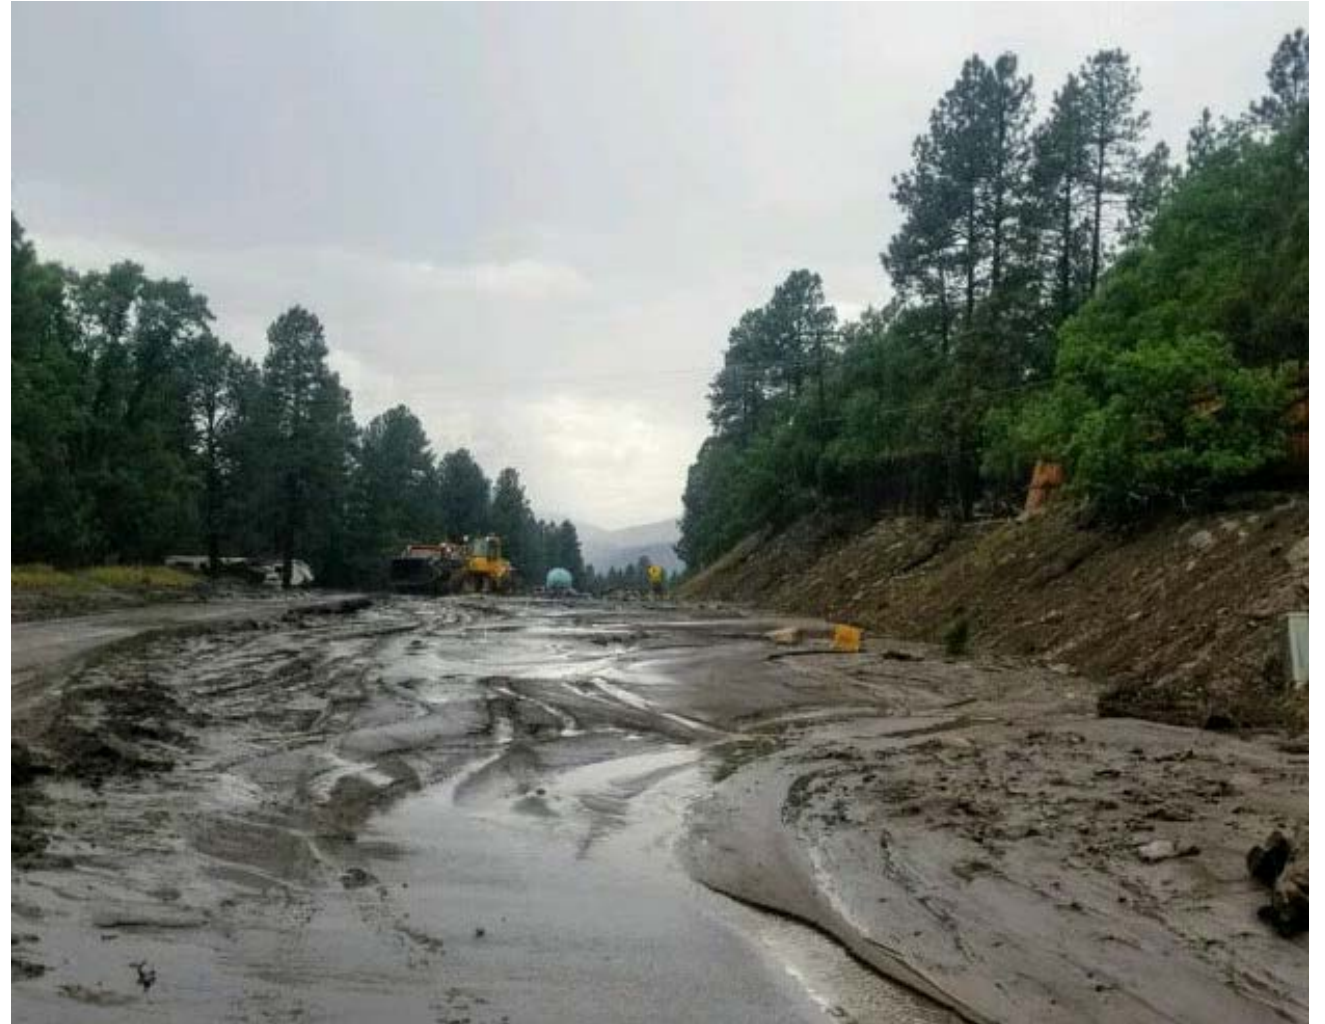
# CDOT Challenges

- 1<sup>st</sup> Mud slide was on July 14<sup>th</sup> on US 550 an MM 40.5 – no closure
- July 17<sup>th</sup> – Mud Slide closed highway from MM 33 -37 and evacuated the KOA- 30 minute response time- equipment and man power was staged in Hermosa
- July 19<sup>th</sup>- more mud at MM 28 to 41.2
- July 19<sup>th</sup> to August 14<sup>th</sup> – had traffic control set up so MTCE could continue to clean mud and culverts
- July 24<sup>th</sup>- more mud

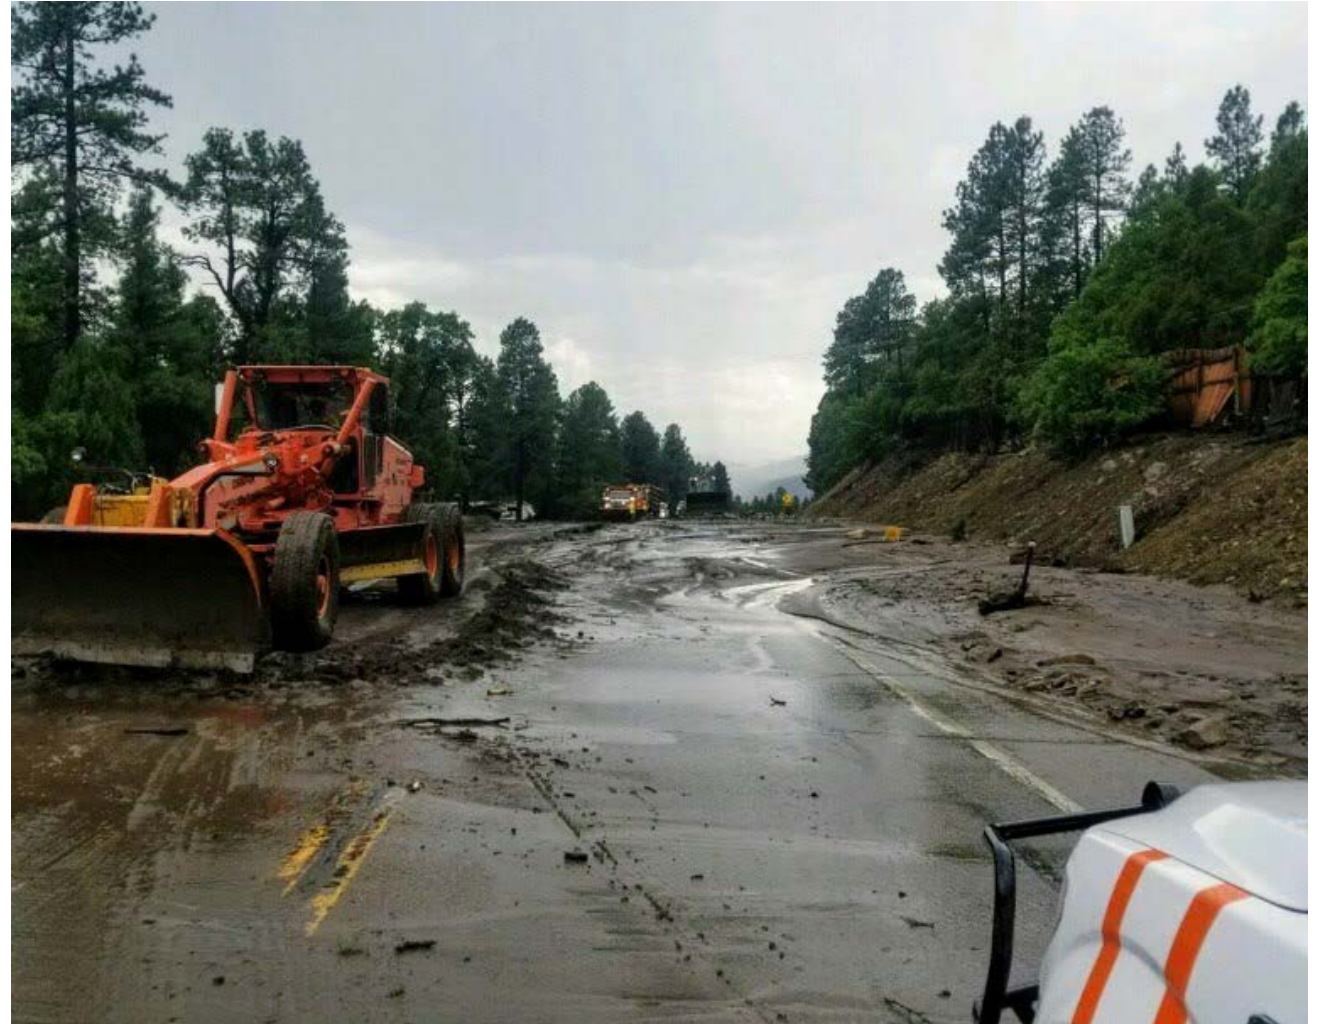
## CDOT Challenges

- August 16<sup>th</sup> thru October Control Measures were being installed
- Clean up of culverts & Install grates
- Clean up debris- logs, rocks, fencing, furniture, etc....
- September 10<sup>th</sup>- Hydroseeding began
- 5,180 Cubic Yards of mud was moved
- \$115, 439 – cost as of October 2018 (this was just man power and moving mud)
- Total- 20 days closed-

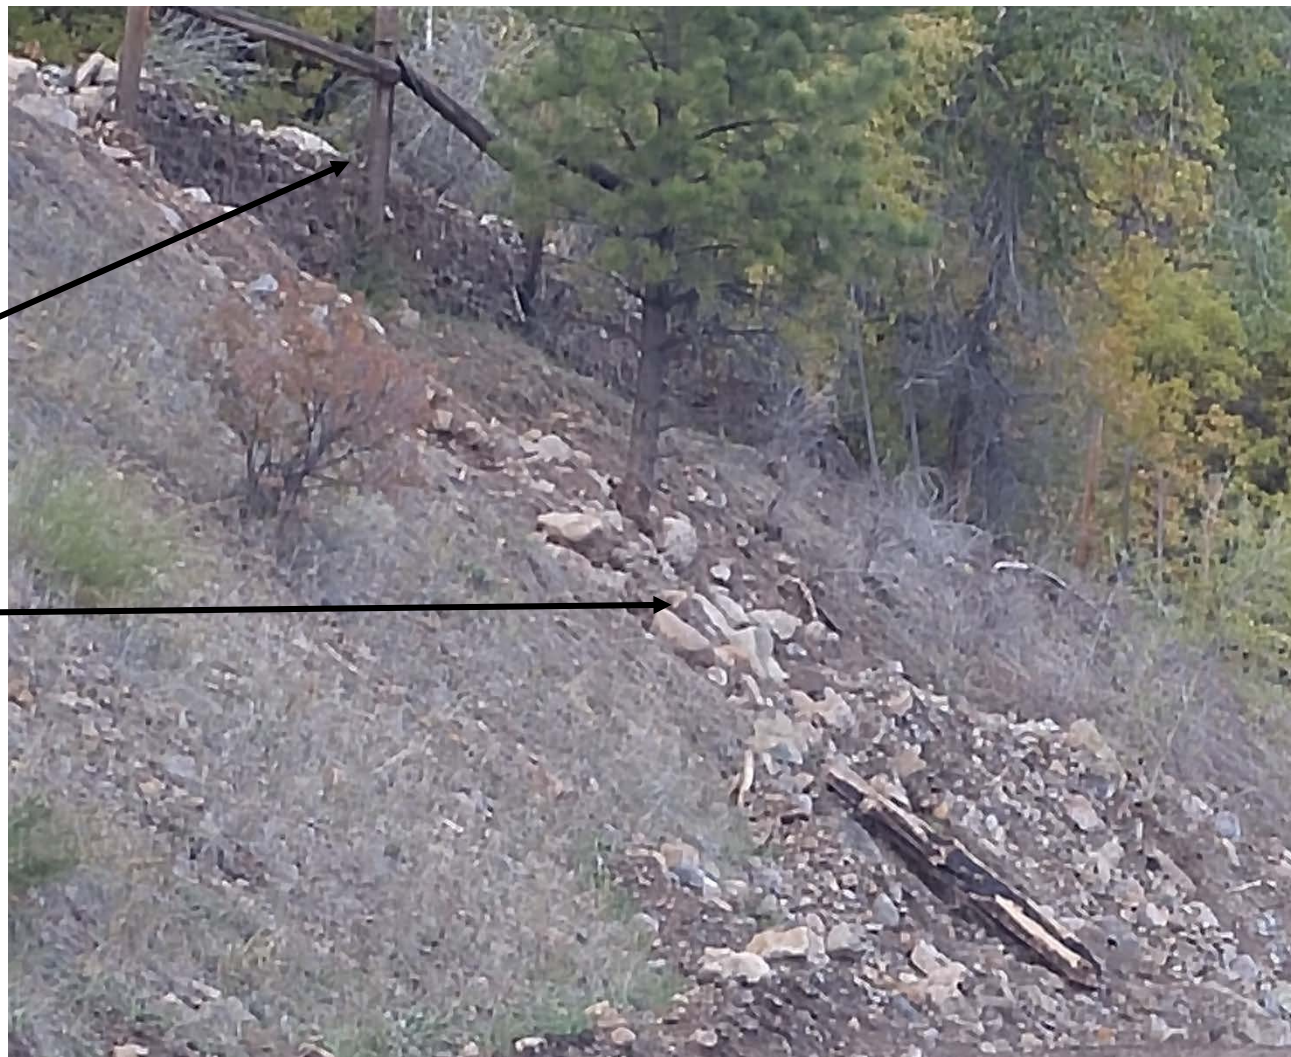
## Run on over cut slope

- Increase of debris and flow onto the cut slope. The top of cut fence is acting as debris rack which contained rock/debris and allowed run off to pass. Soils are rocky from rock fall and talus.

- Reshape rundown cuts with rock checks and revegetate.

- Measuring or calculating basin cubic feet per second (cfs) should be considered before design new rundowns

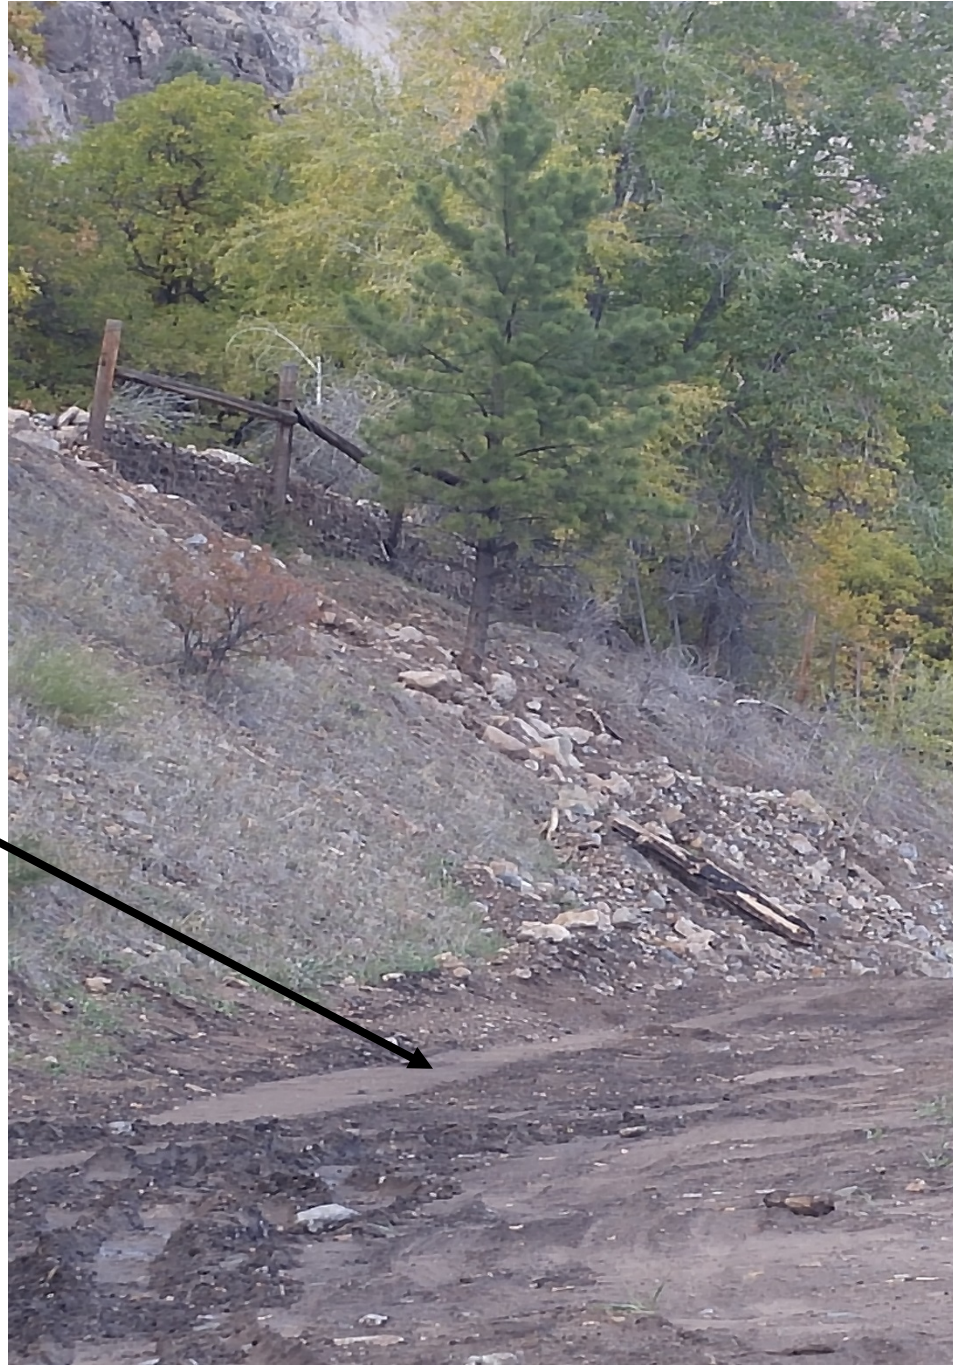
Roadside ditches are disturbed due to post fire run off event. Reseed with native seed mix in between storms. Hand seed and rake to cover.

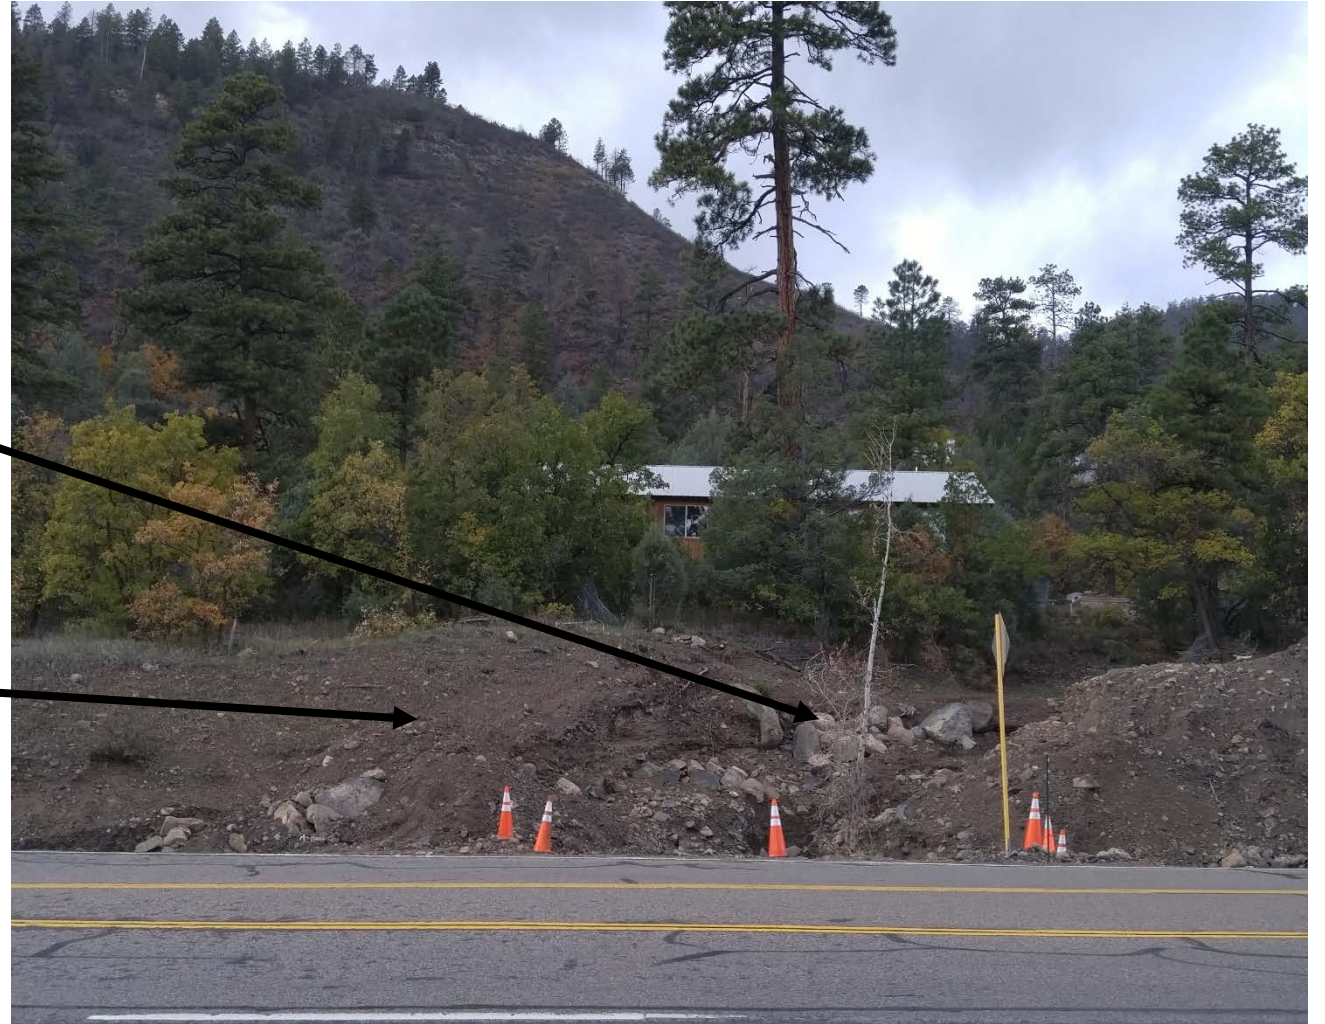
# Existing Rundowns and channels

- Use existing boulder to reshape channels and build H-pile trash racks above culvert racks
- Existing highway cut slopes are steep and bare.
- Revegetate cut slopes and if possible, construct cutoff ditches to divert water to channels

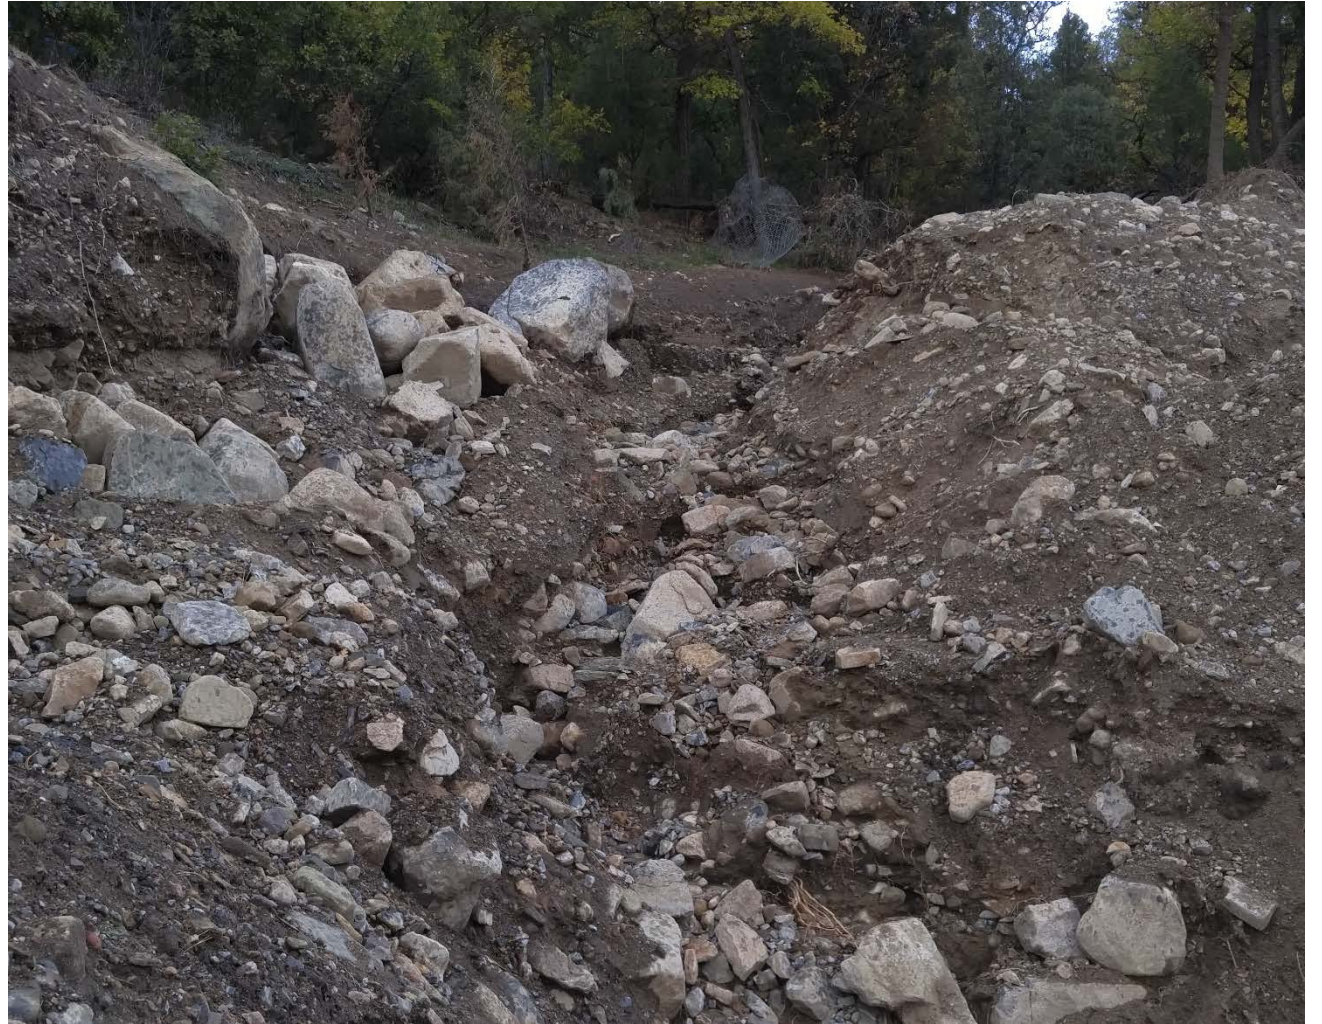
## previous channel looking upslope

- H-pile and boulders to reshape channel.
- If easement of Right of Way allows, consider flattening slope gradient to decrease channel velocity.

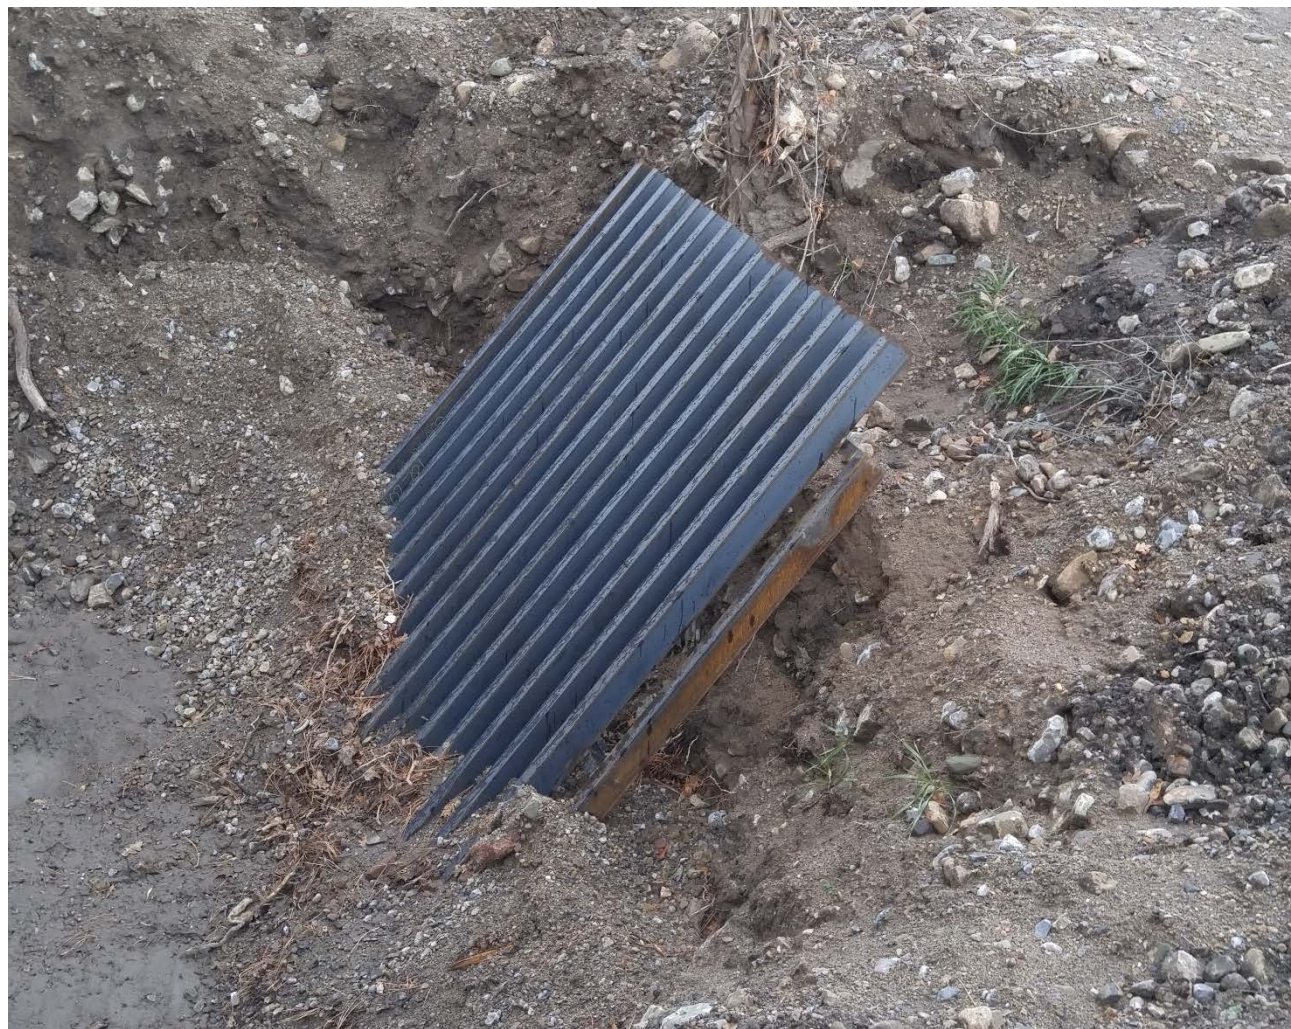
# Trash rack at culvert below channel in previous slides

- Reinforced channel  
above this trash rack will  
reduce load on this rack

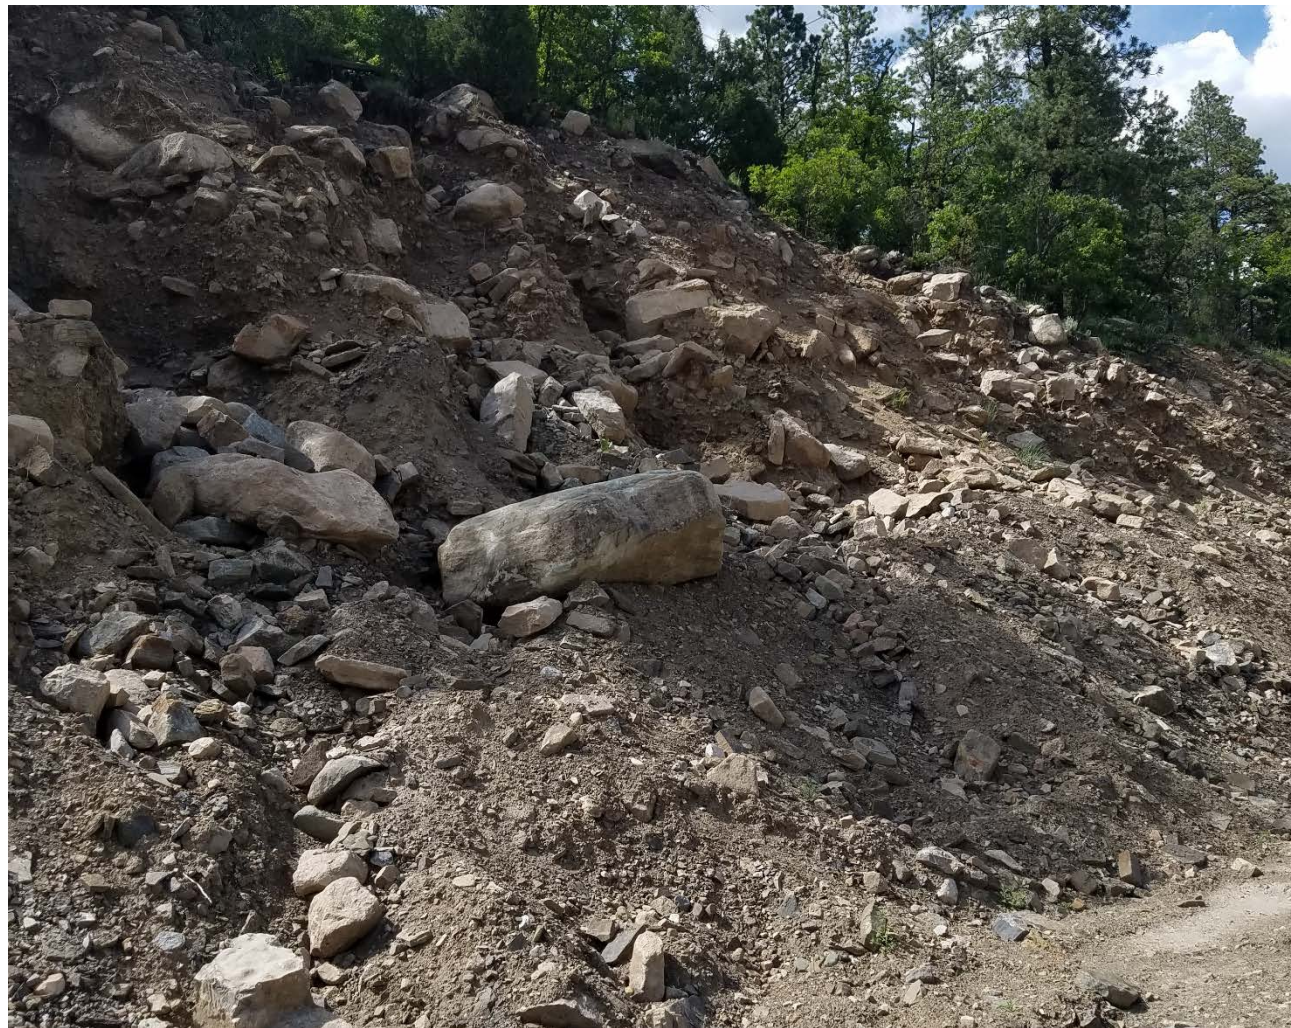
# Slope Erosion and Bank Stabilization Limitations

- To Stabilize or not to stabilize?
- To Seed or not to Seed?
- Timing?
- Land Ownership and limited space
- Cost Effectiveness?
- Long Term Planning?
- Funding?
- Ideas?

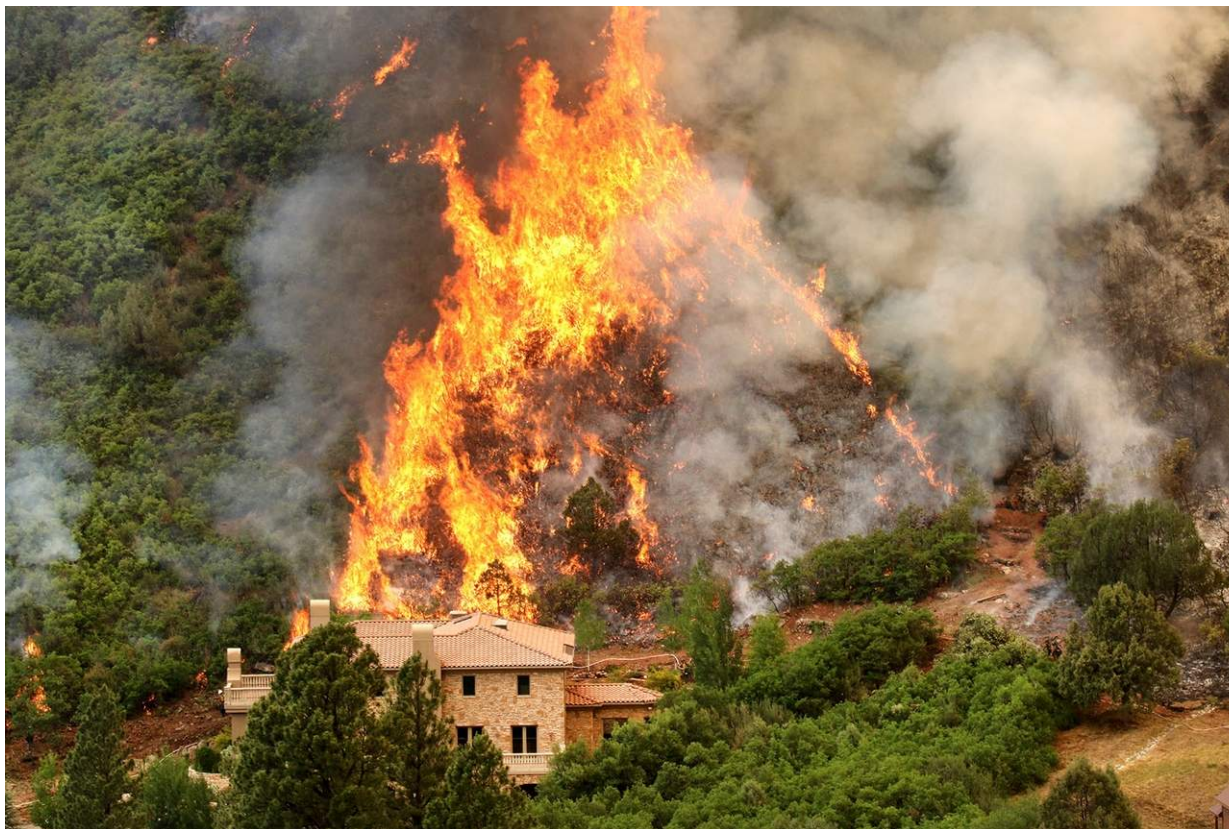
# County Road 202 – during 416 fire

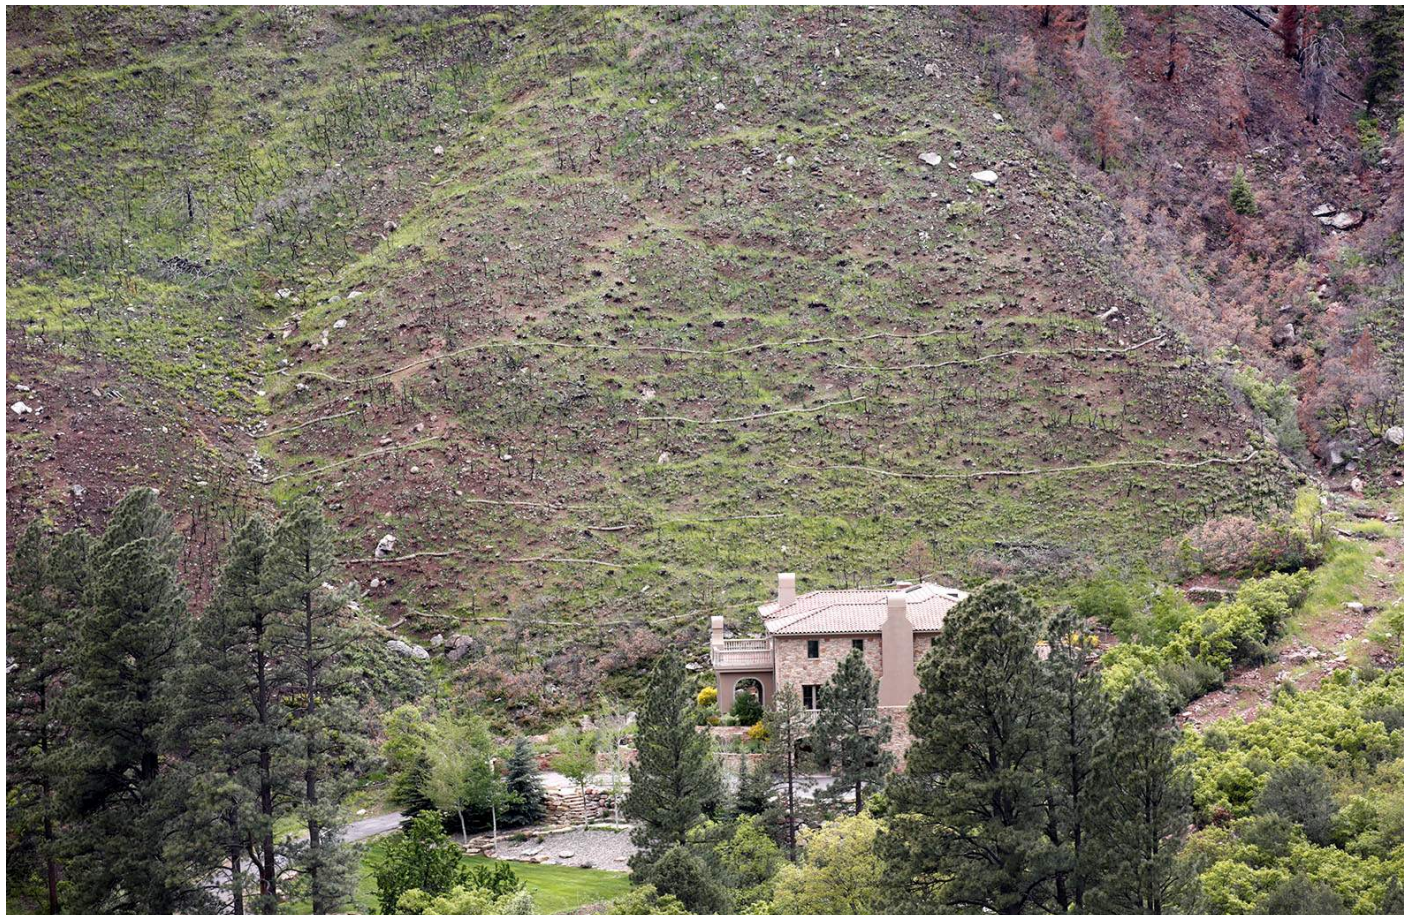
# County Road 202 - a year after fire

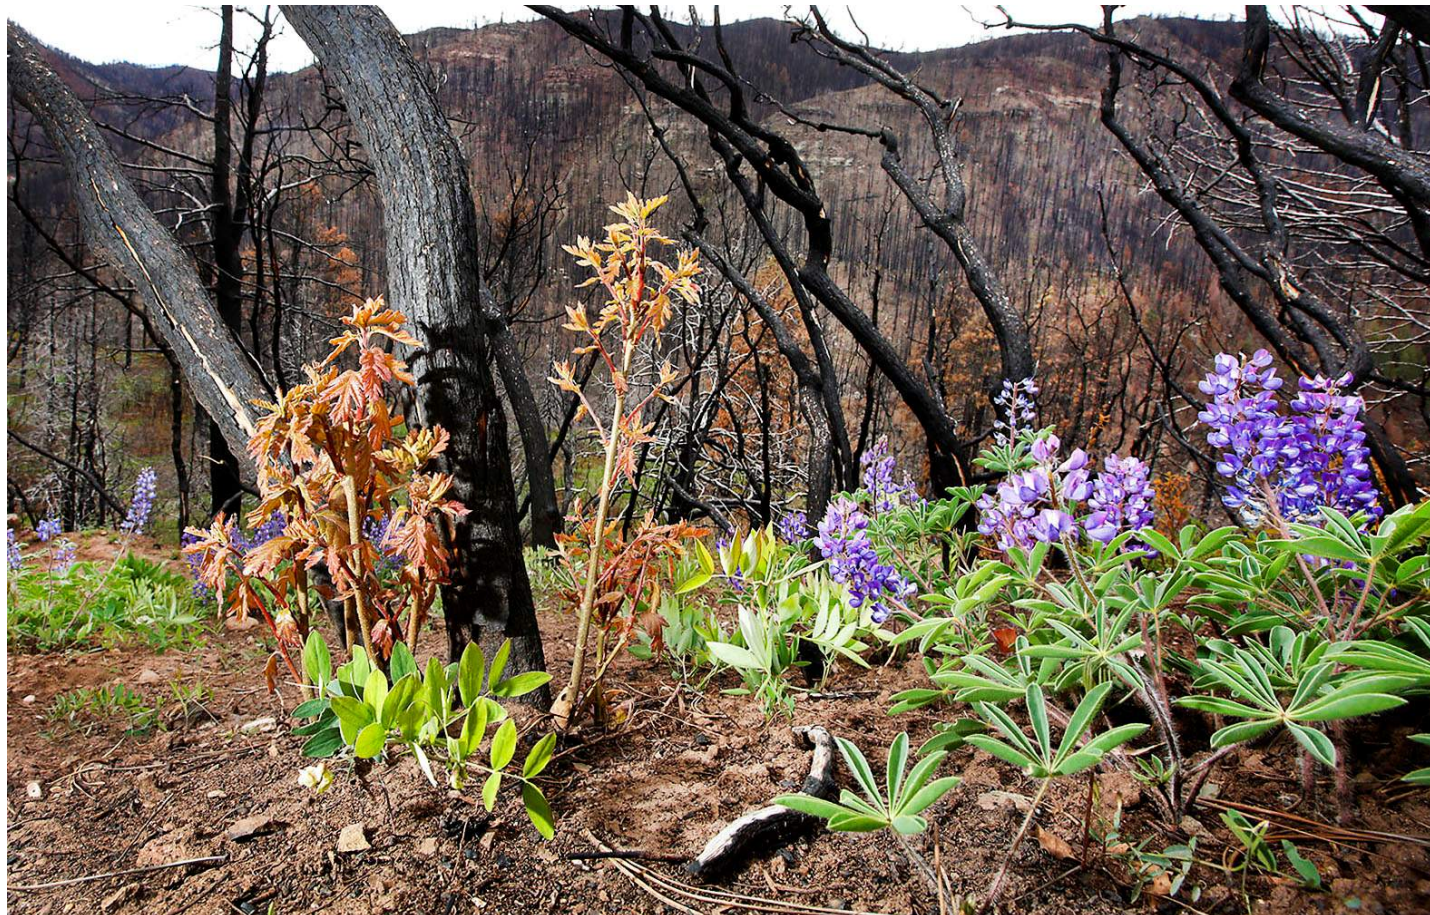
# Hermosa Creek- a year after the fire
